# **Western Port Local Coastal Hazard Assessment Report 6 (R06) – Review of Representative Locations**

**September 2014**

Project Name	2548-01R06v05
Client	Melbourne Water
Client Project Manager	Kristina Sestokas
Water Technology Project Manager	Christine Lauchlan Arrowsmith
Report Authors	TJW, JXM, CLA, GJR, Neville Rosengren
Job Number	2548-01
Report Number	R06
Document Name	2548-01R06v05_Review_of_Representative_Locations

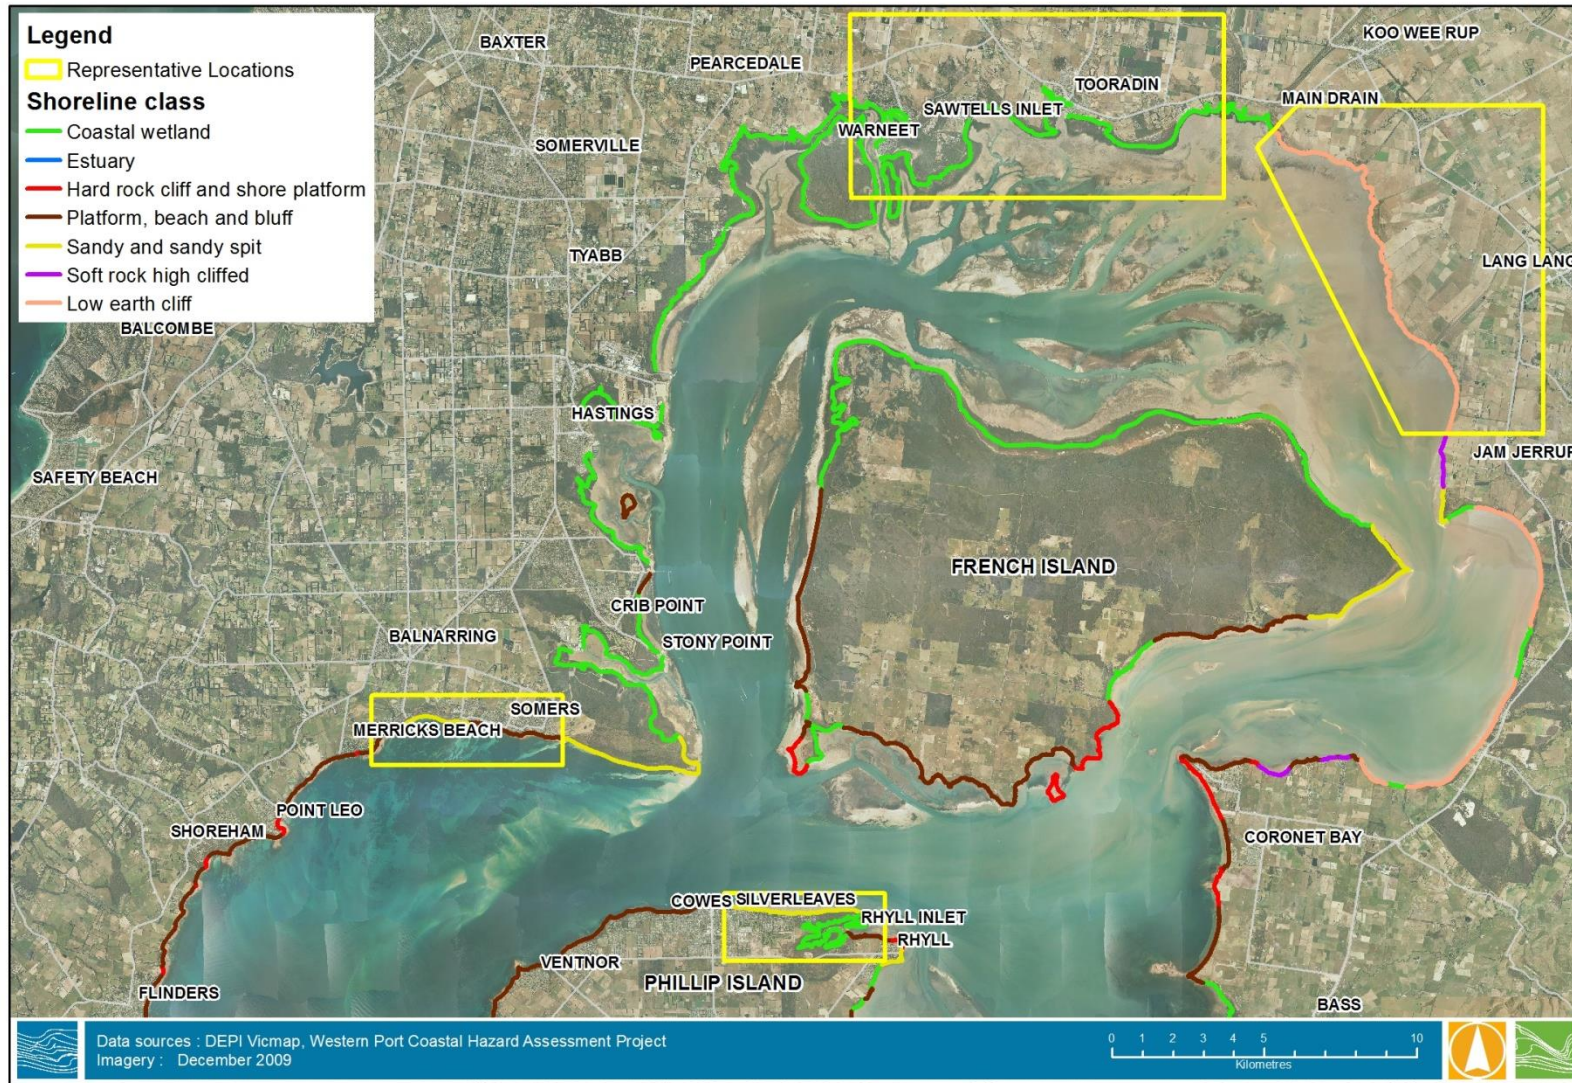
**Figure 1-1 Outline of Part B Local Coastal Hazard Assessment Locations and Extents**

An outline of each representative location study extent is shown in Figure 1-1. This report describes the assessment of the four representative locations.

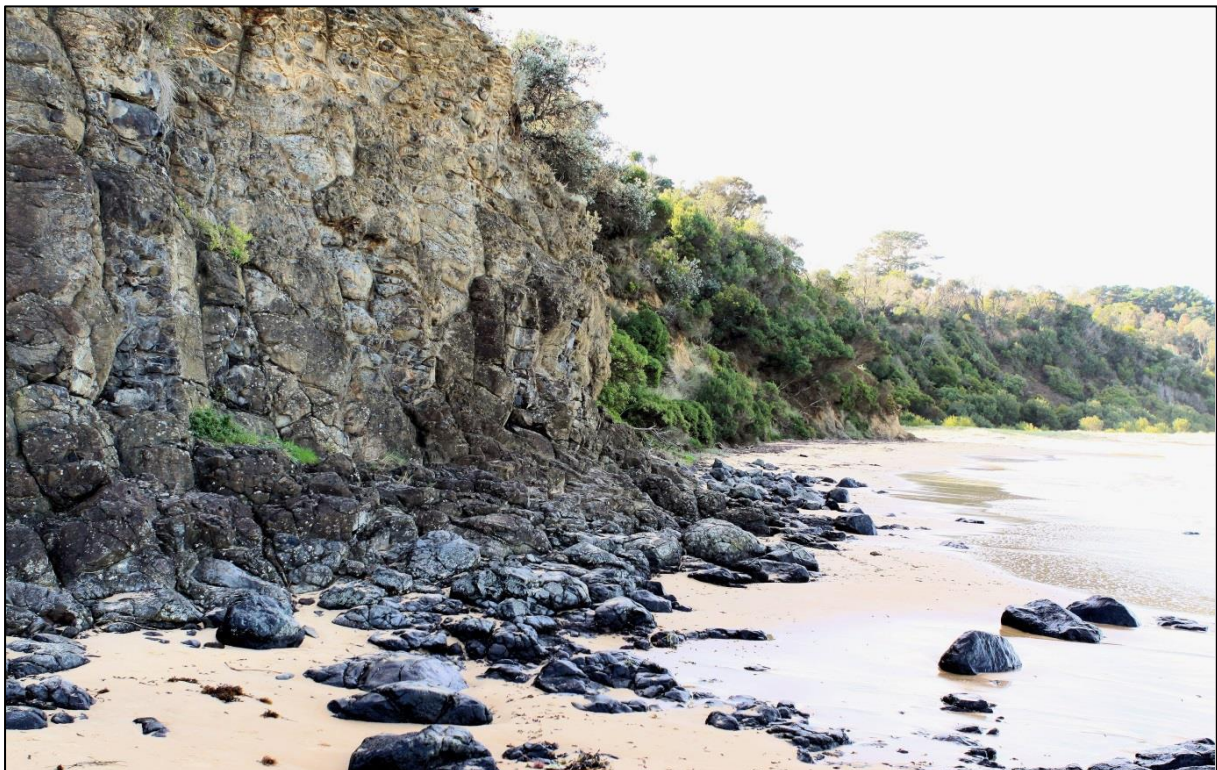
Although the shoreline and seafloor is likely to be underlain by an extensive planed-off rock shelf, there is only discontinuous exposure and the near shore depths are quite variable. A shore platform and reef flat of variable elevation is exposed at low tide between Point Sumner and Balnarring Beach foreland and also from Somers to South Beach. It is mainly composed of fresh to weathered basalt.

**Figure 2-4** Cliff of Columnar Basalt at Sumner Point. Weathered basalt at cliff top and in bluffs to the east. Sand covers the Shore Platform. (Photo: Neville Rosengren, 7 June 2013).

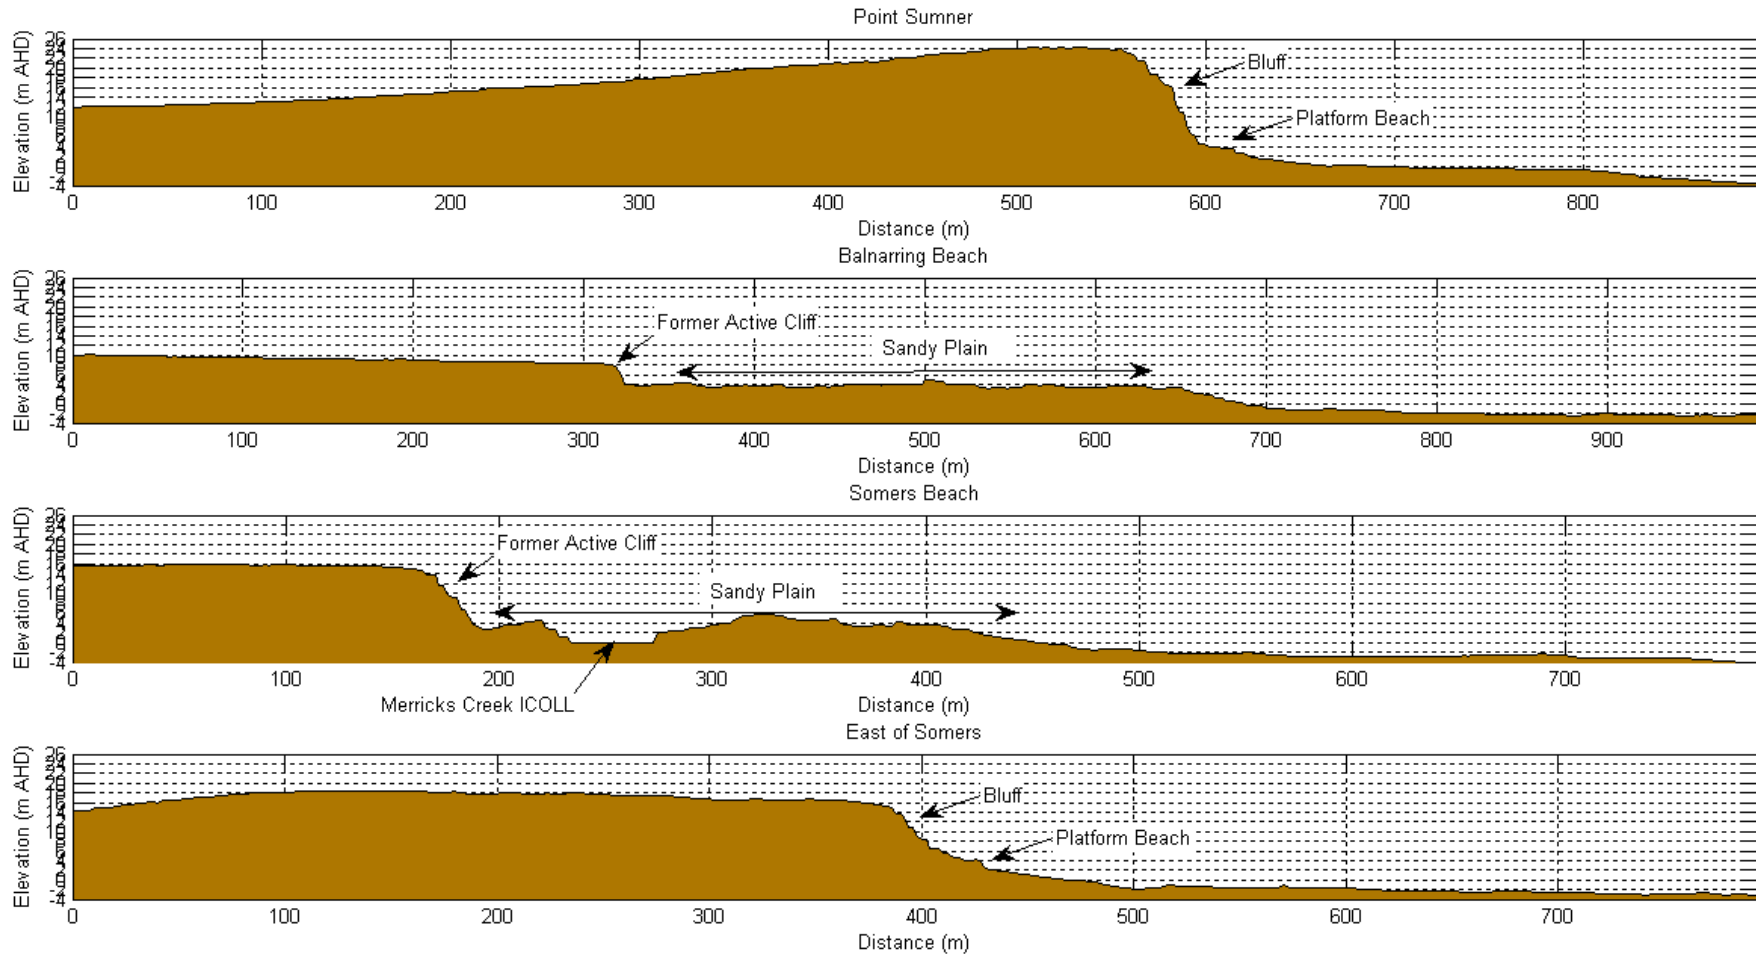
The beach face is generally narrow and steep. A substantial volume of seagrass can accumulate on the beach face at low tide and in places forms a cover up to one metre thick. The headland at Balnarring Beach is built on a slight rise in the level of the shore platform that anchors the foredune ridges.

**Figure 2-5 Representative Cross-Sectional Profiles of the Somers Study Area (cross-section locations displayed in Figure 2-3)**

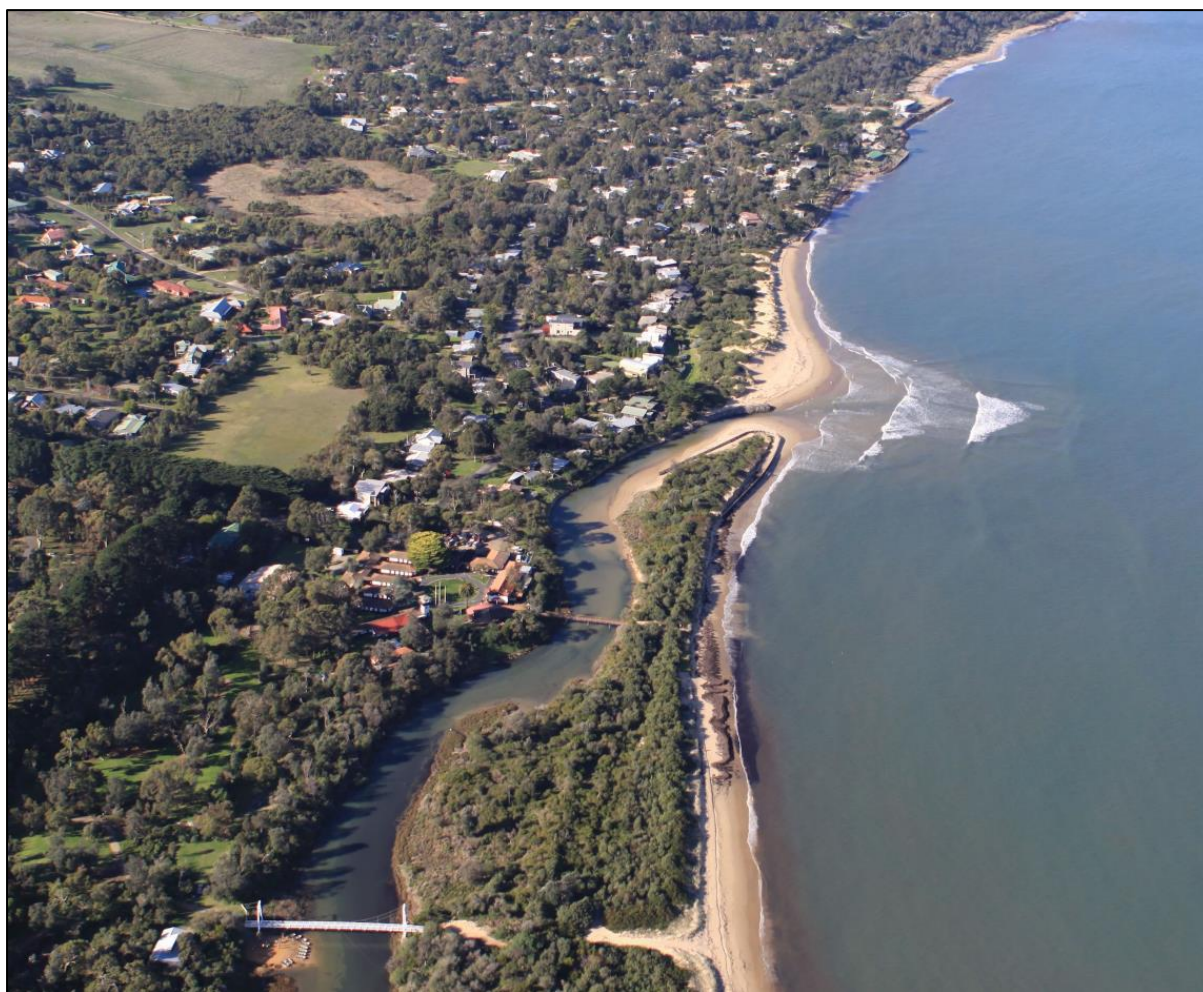
The Merricks Creek ICOLL has historically been deflected eastward by the longshore drifting of sediment. In the 1960s, however, the location of the creek entrance (mouth) was fixed by via the construction of training walls on either side of the creek outlet.

**Figure 2-6 Merricks Creek Mouth (Photo: Neville Rosengren, 8 June 2013)**

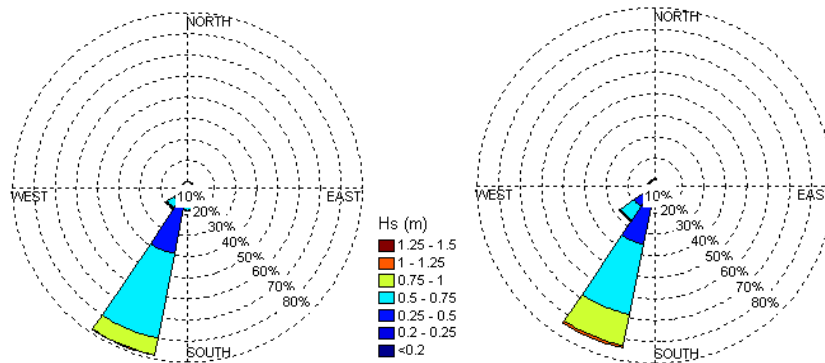
It is evident from close analysis of the wave climate that wave conditions at Somers are modulated by ebb and flood tide current flows through the Western Entrance. During ebb tide conditions, a combination of wave-current blocking and wave-current refraction tends to reduce wave heights compared to flood tide conditions.

**Figure 2-7 Wave Roses – Summer (2003), and Winter (2003)**

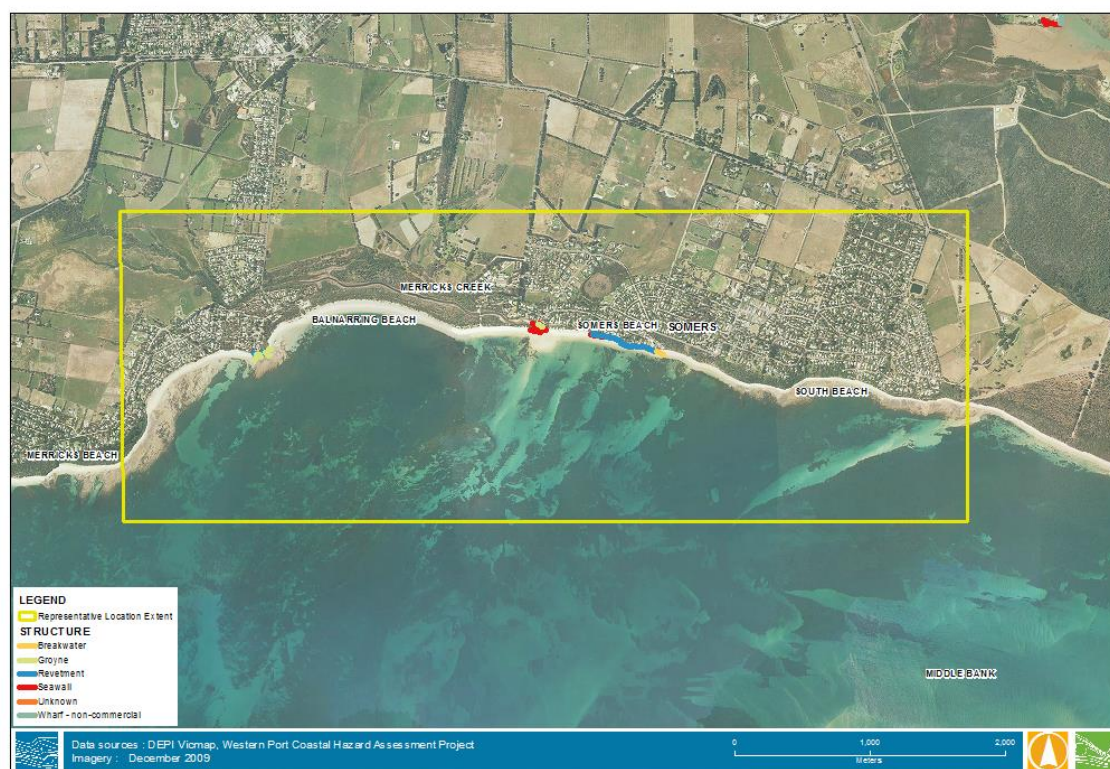
**Figure 2-9 Extent of the Coastal Structures in the Balnarring-Somers Study Area**

Significant lengths of the study area shoreline have been modified by the construction of coastal structures in an effort to protect development from the highly variable nature of the shoreline that is observed within this study area. The existing coastal structures as defined by the DEPI coastal asset database are shown in Figure 2-9.

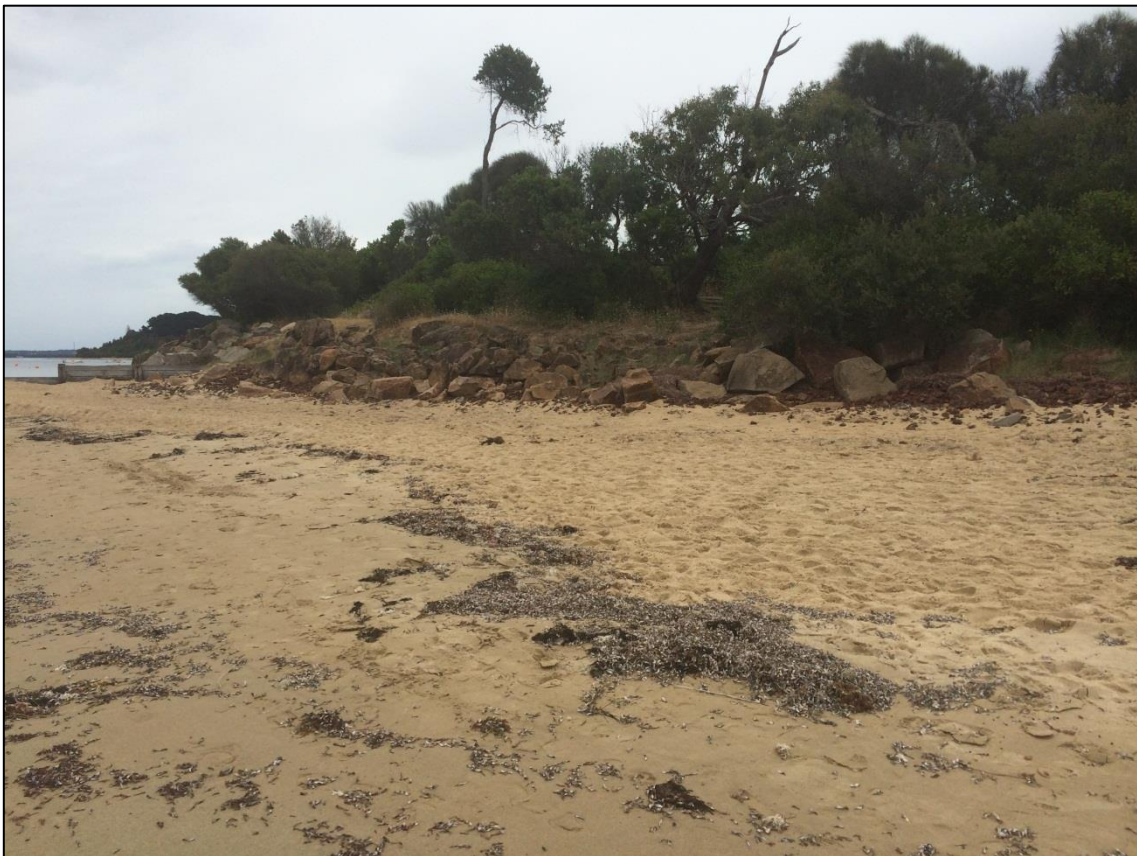
**Figure 2-11 Rock Revetment at Balnarring Beach**

The rock revetment is located along the dune line to the rear of the timber groynes. It consists of dumped rock of a range of sizes and the surface is currently uneven and eroded in a number of locations. The revetment provides protection to the dune line against the impact of waves and associated shoreline erosion.

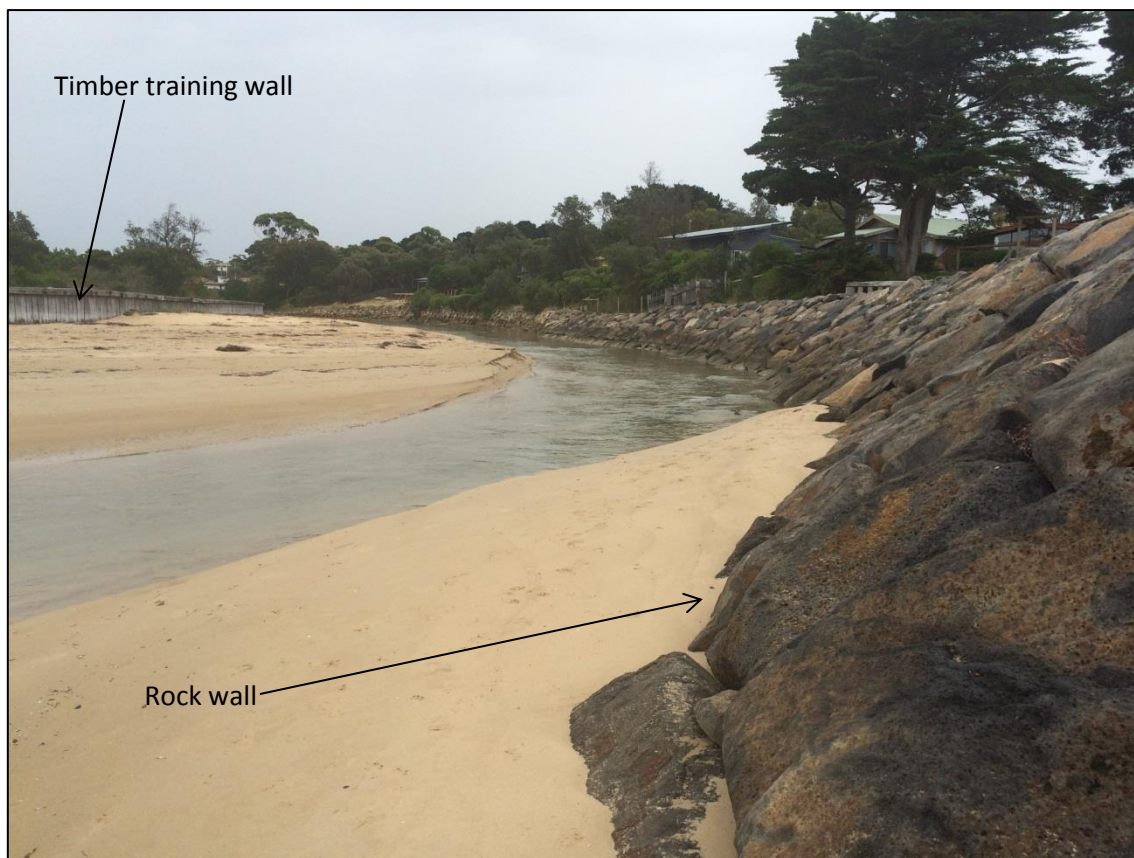
**Figure 2-12 Merricks Creek Entrance Structures**

Currently the entrance training walls consist of the western timber training wall and an extensive rock training wall along the eastern side of the entrance, extending for some distance upstream, as shown in Figure 2-12.

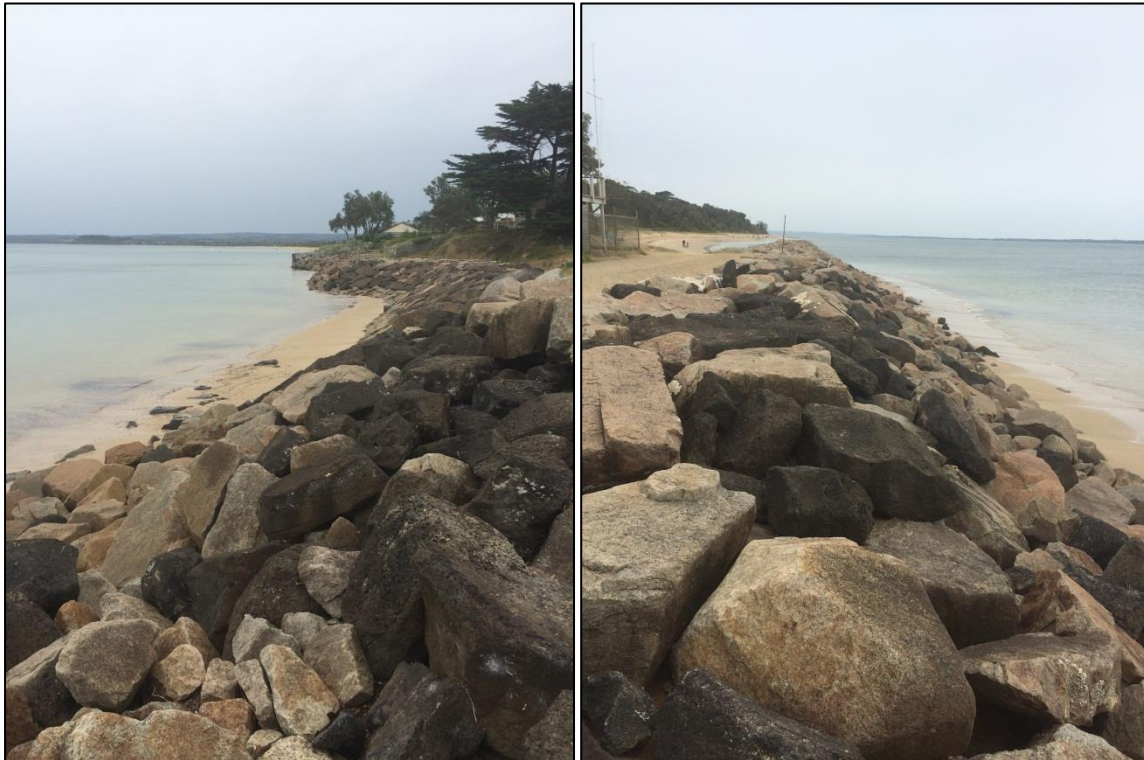
**Figure 2-13 Sea Wall at Somers in front of the Yacht Club**

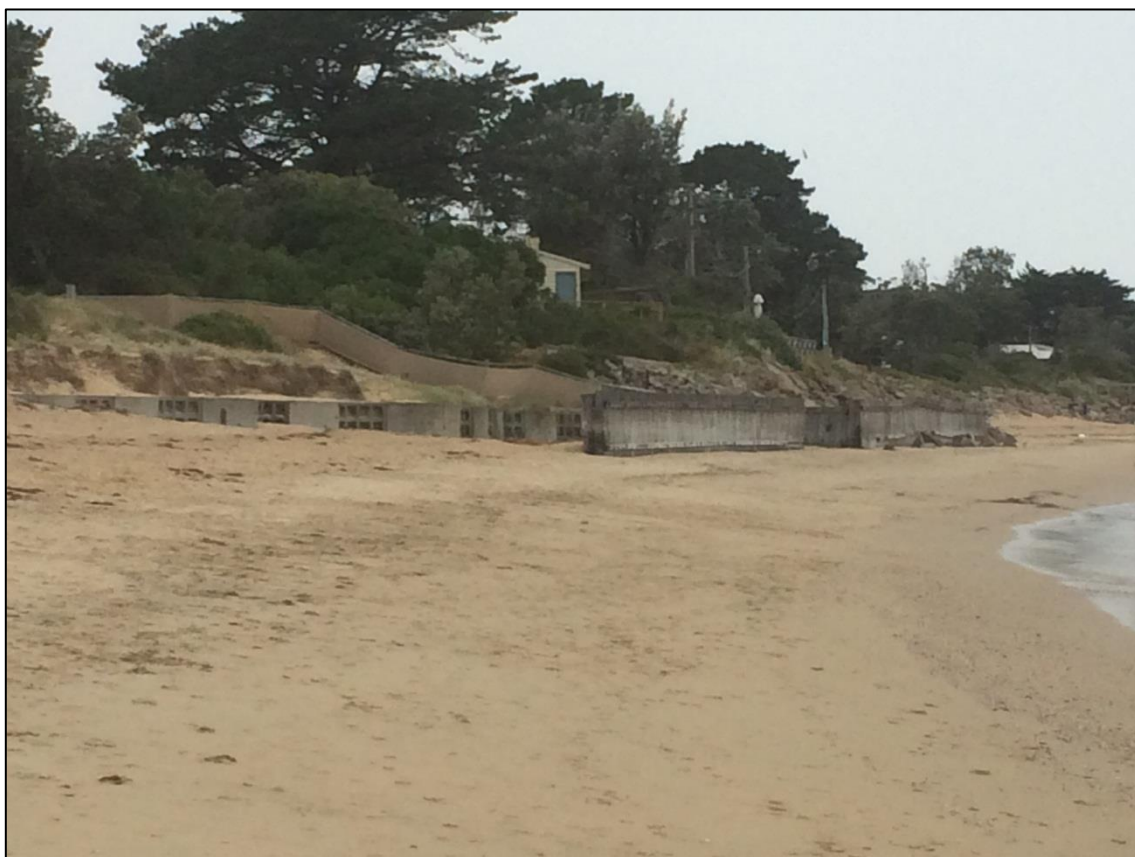
Further west along the beach are sections of private sea wall, which have been outflanked previously by erosion, Figure 2-14.

**Figure 2-14 Sections of Private Sea Wall at Somers**

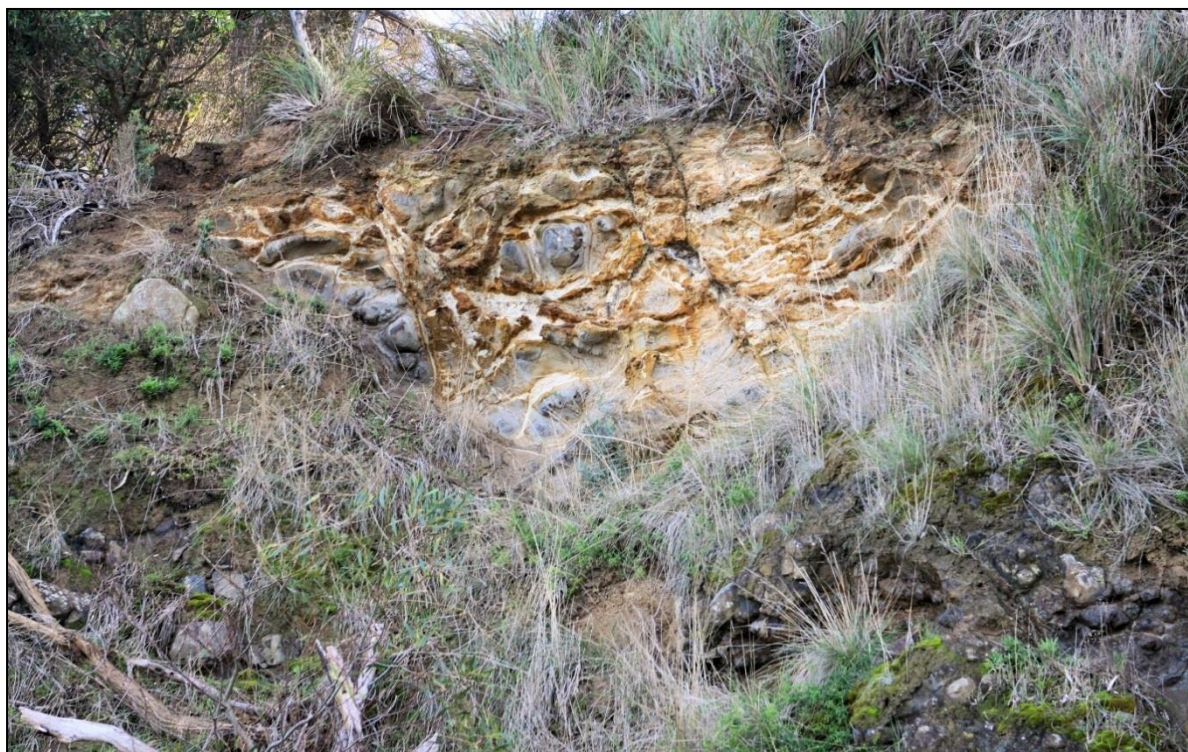
Shore platforms of variable elevation are exposed at low tide below marginal bluffs and narrow platform beaches at Point Sumner and Balnarring Beach foreland, and also from Somers to South Beach. The shore platforms are gently sloping ( $\sim 0.4^\circ$ ) and can be up to 200 m wide at low tide. The shore platforms are composed of fresh to weathered basalts. The bluffs are composed of fresh to weathered basalts and are overlaid by Baxter Formation Ferruginous Sandstone (Figure 2-17).

**Figure 2-17 Baxter Formation Ferruginous Sandstone overlying Weathered Basalt, Sumner Point (Photo: Neville Rosengren, 7 June 2013)**

The width of the platform beaches in front of the bluffs at these locations is relatively short and the bluffs are therefore considered potentially vulnerable to slope failures initiated by destabilisation of the base of the bluff due to sea level rise.

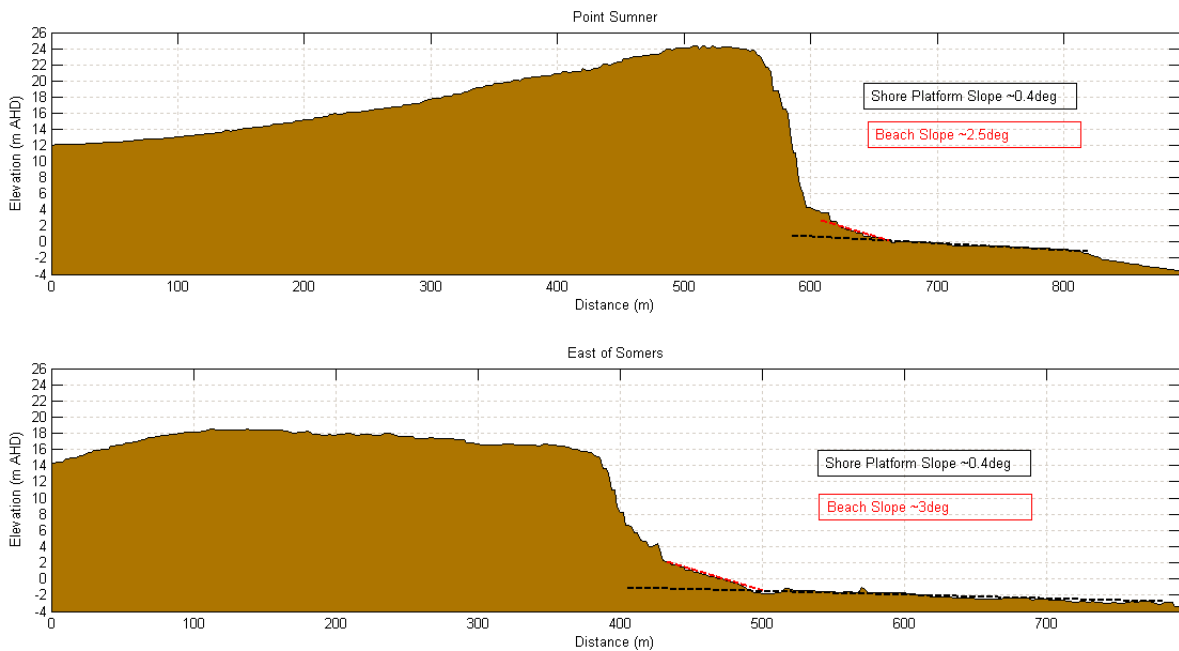
The hazard extent has therefore been considered to extend landward from the base of the bluff by a factor of 5 times the height of the bluff along these shorelines. This results in a final failure slope of approximately  $11^{\circ}$  along these bluffs where they are likely to be reactivated by sea level rise.

**Figure 2-18 Platform Beach and Bluff Slope Analysis**

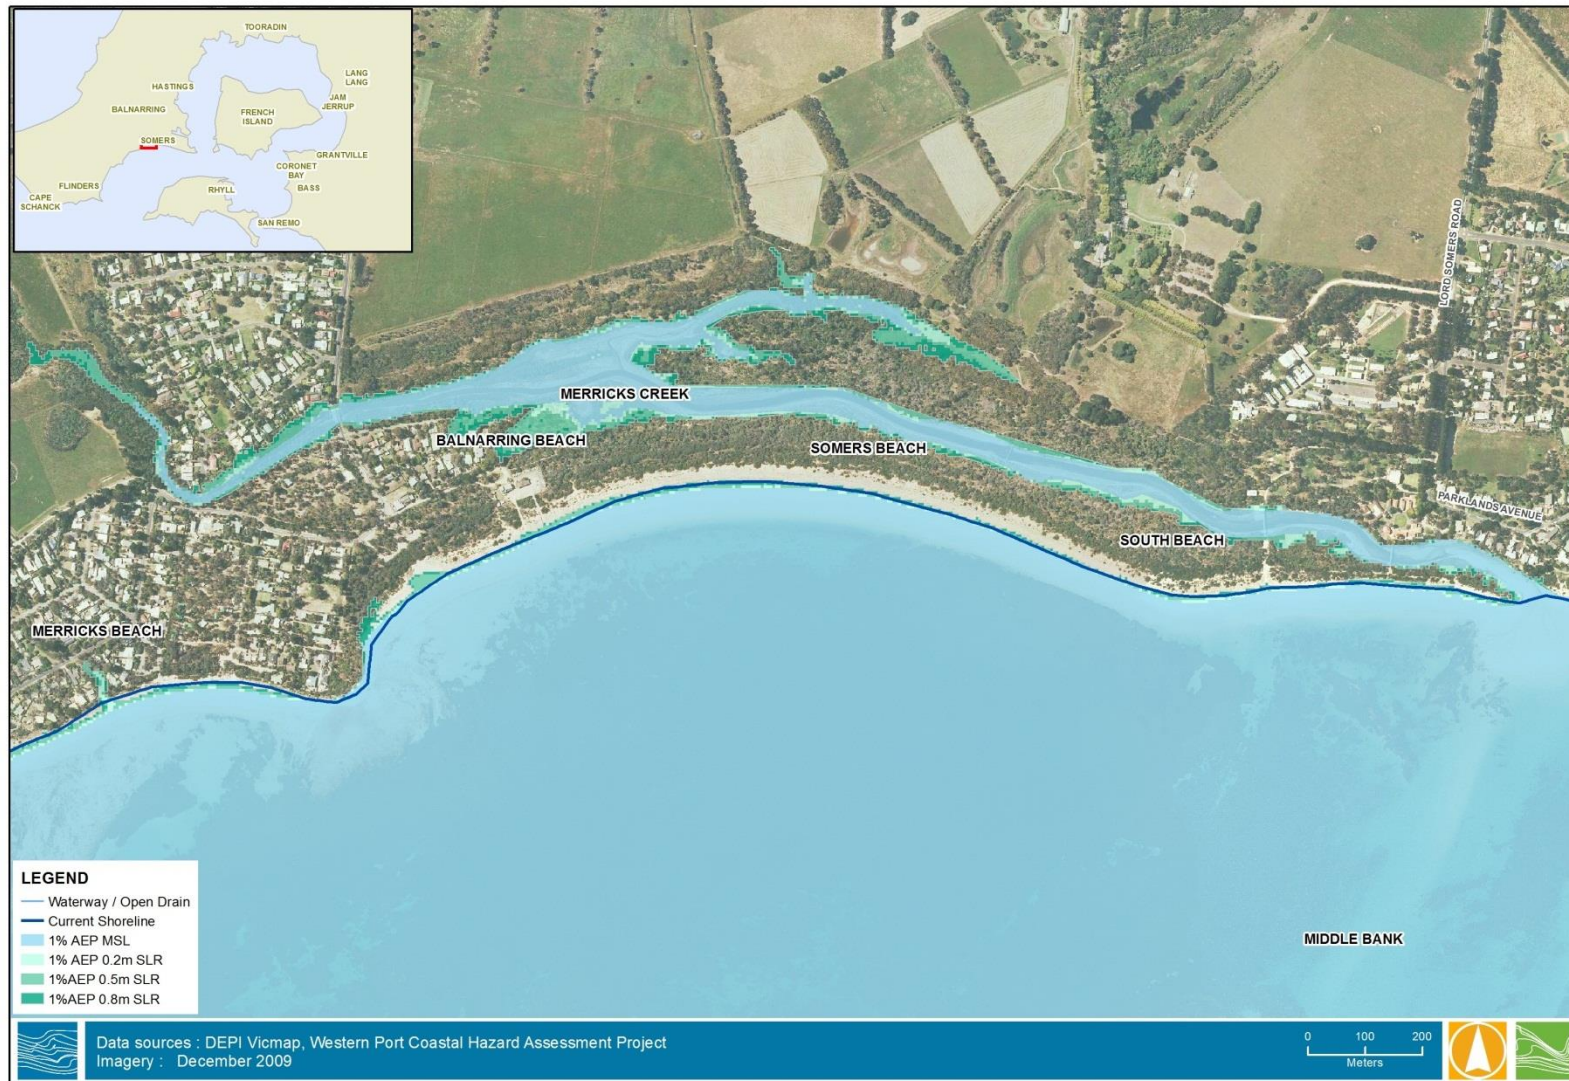
The 10% AEP catchment flows have been generated for Merricks Creek and modelled for each sea level rise scenario. A summary of the analysis used to determine the 10% AEP flows is provided in Appendix B. The resultant inundation extents for each scenario are shown in Figure 2-20 and show virtually no difference in inundation extent for each sea level rise condition. This is because the entrance condition of the creek is the dominant control of the water levels upstream.

**Figure 2-19 Storm Tide Inundation of Merricks Creek (1% AEP Storm Tide under Existing Mean Sea Level)**

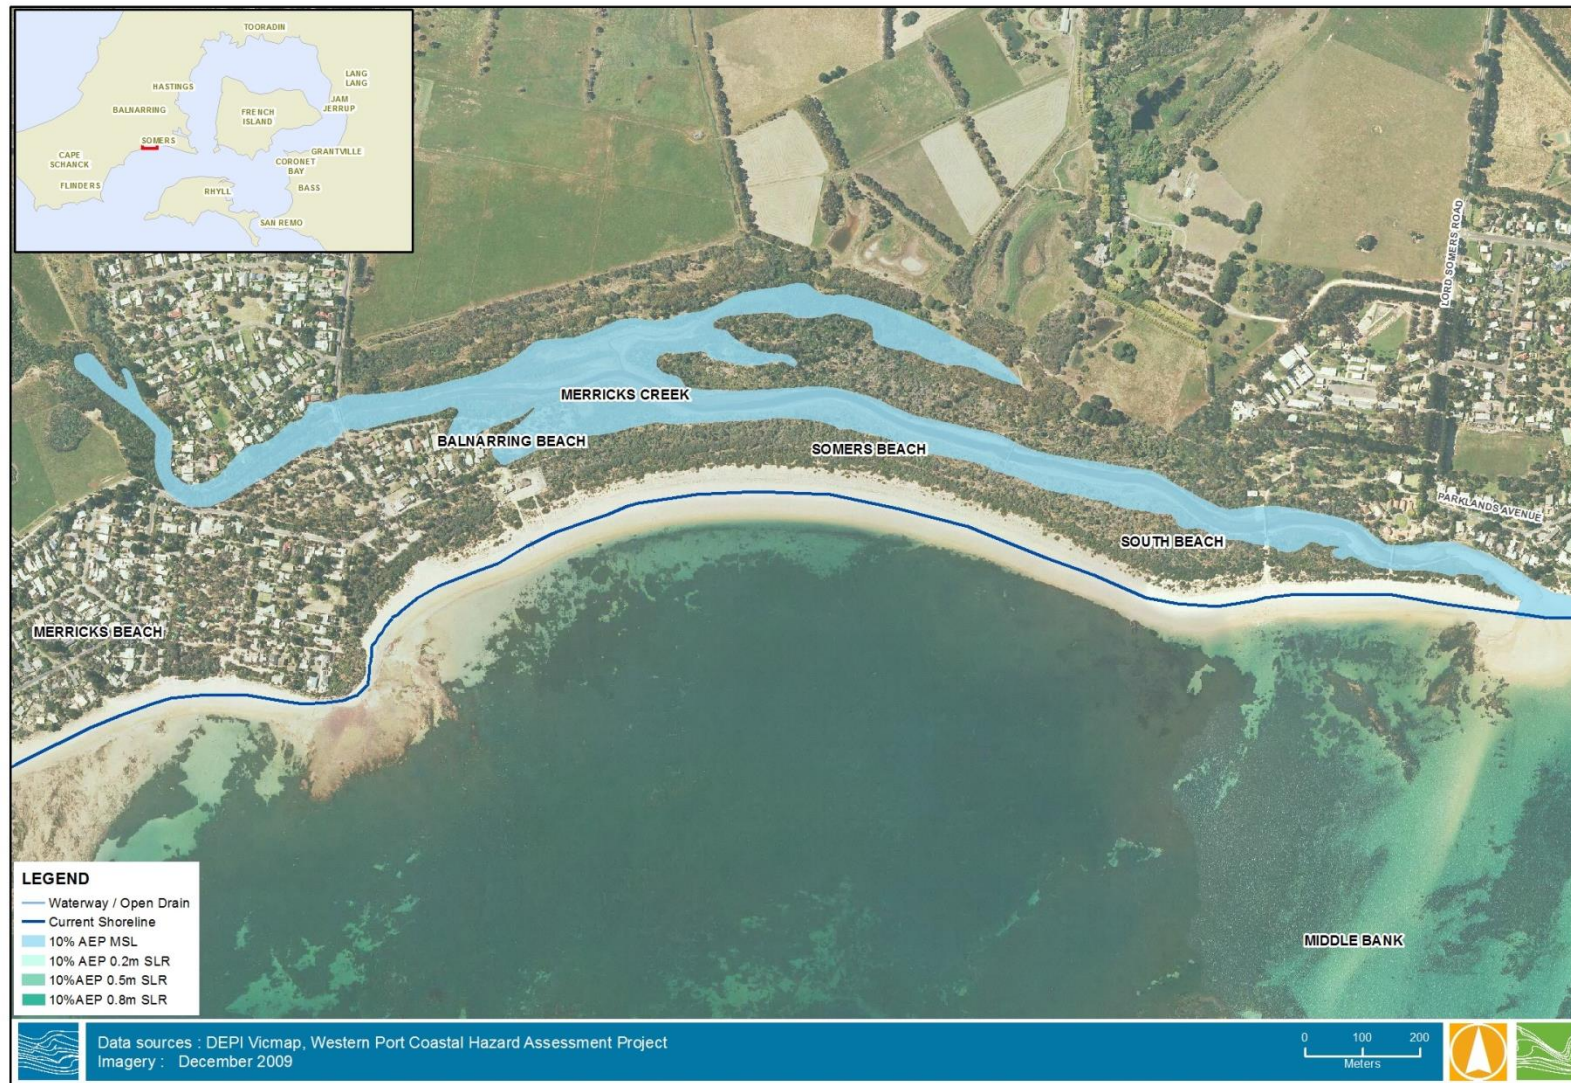
This is also the case within Merrick's Creek, where the storm tide is contained within the vegetated estuary corridor due to the terrain in this area. This is shown in Figure 2-19, where the peak storm tide elevation at the Merricks Creek entrance has been mapped throughout the estuary.

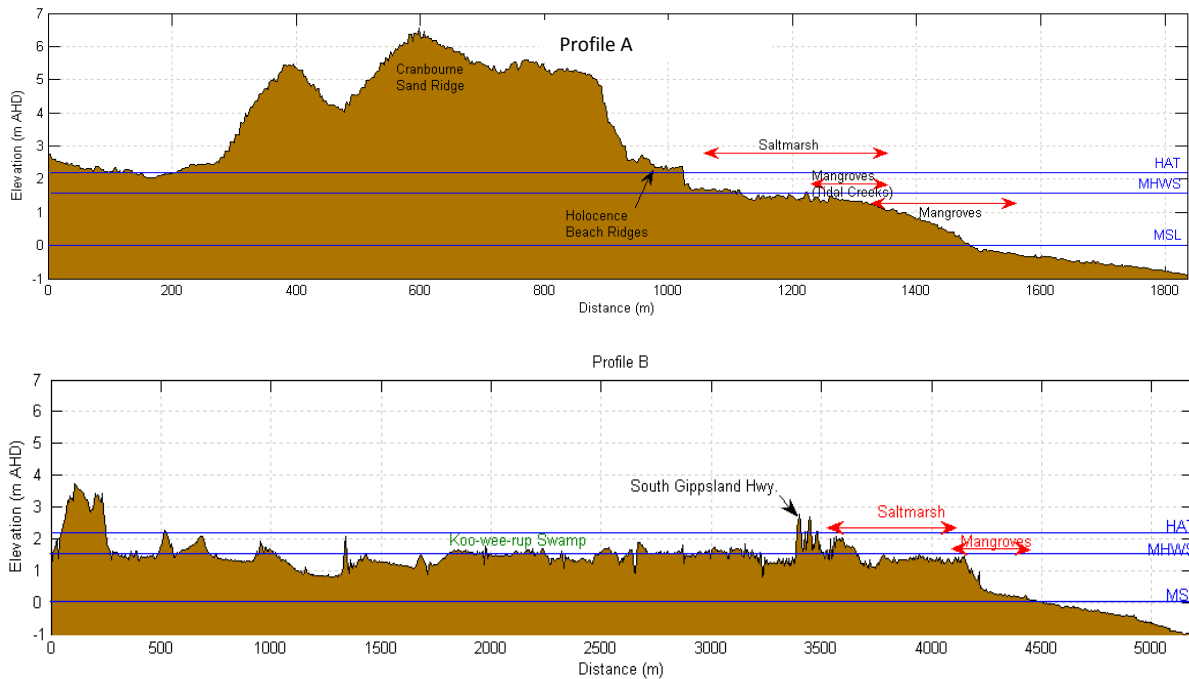
**Figure 3-4 Representative Profiles of the Tooradin and Coastal Villages Study Area**

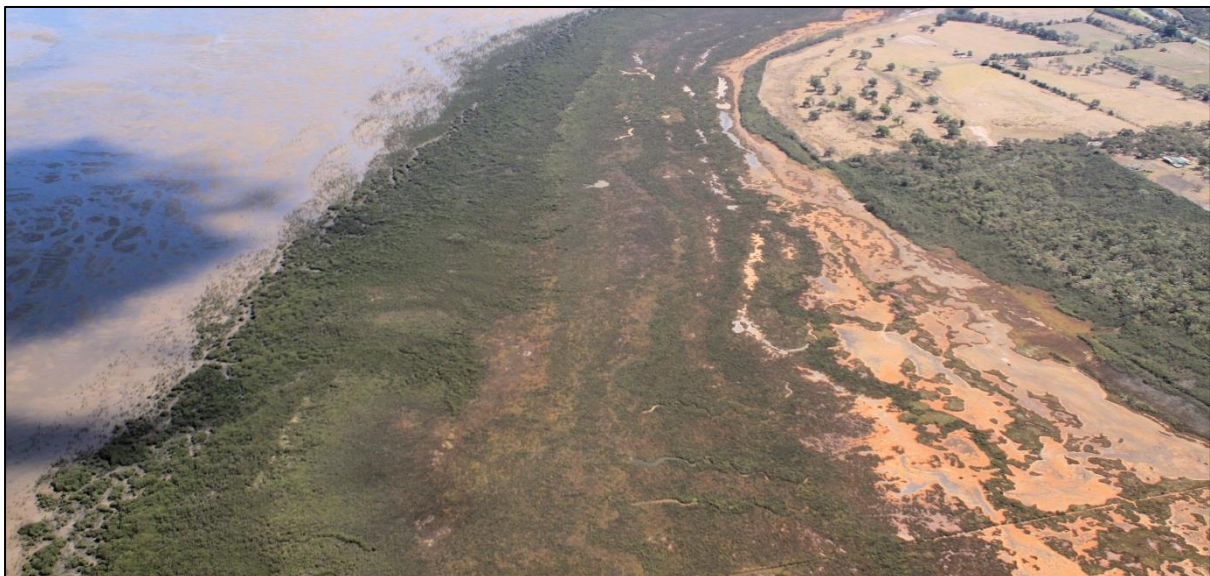
The zone is crossed by a close-spaced, co-ordinated branching network of tidal creeks that in places are incised over 1 m into the substratum of the saltmarsh zone and continue across part of the mangrove zone. There is no clear topographical variation across the saltmarsh zone apart from creek incisions and shallow enclosed depressions, usually at the rear of the zone but in places central in the marsh. Some marshes display sets of sub-parallel vegetation zones in the central and rear areas that are a reflection of micro-topographical variation – ridges and swales with amplitudes of 0.2 m to 0.4 m. These are chenier ridges of sand, shell and wrack deposited during storms and swash-built beach ridges deposited before a broad, continuous mangrove community established.

**Figure 3-5 Pools and Bare Ground at the Rear of Saltmarsh and Low Chenier Ridges – West of Tooradin Airport (Photo: Neville Rosengren, 20 March 2013)**

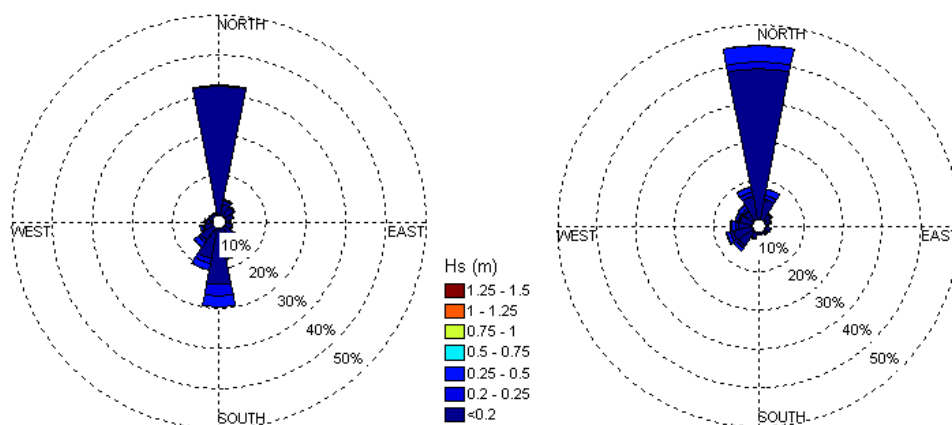
Waves along the study area are generated locally within the northern and western arms of Western Port. The confined fetches and shallow depths in this region of Western Port result in relatively small waves, generally less than 0.5m (Figure 3-7). Due to the large tidal range and low profiles, the amount of wave energy that impacts the shorelines is very strongly modulated by the phase of the tide.

**Figure 3-7 Wave Roses Summer (2003) & Winter (2003)**

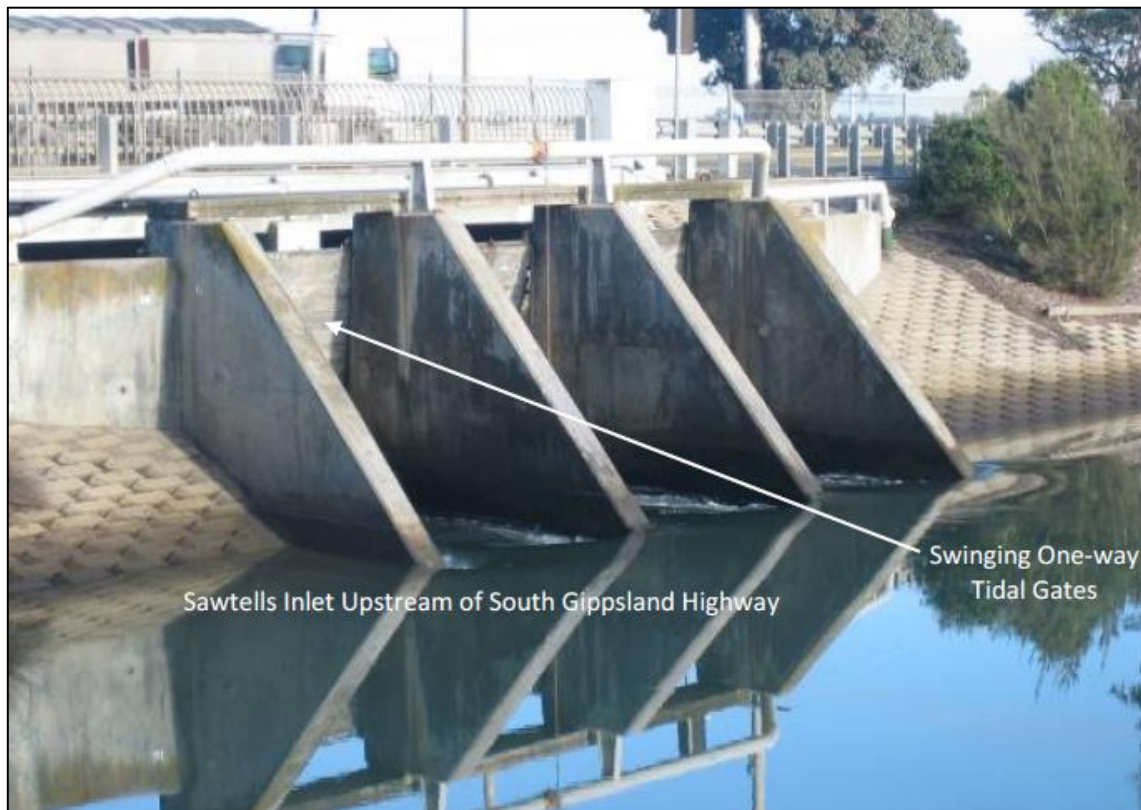
**Figure 3-9** Sawtells Inlet Tidal Gates

These structures comprise the Sawtells Inlet tidal gates and adjacent sea wall and the rock revetment at the Tooradin boat ramp, as shown in Figure 3-9 and Figure 3-10. The remaining structures located are associated with boat ramps or boating/recreational facilities and are shown in Appendix C.

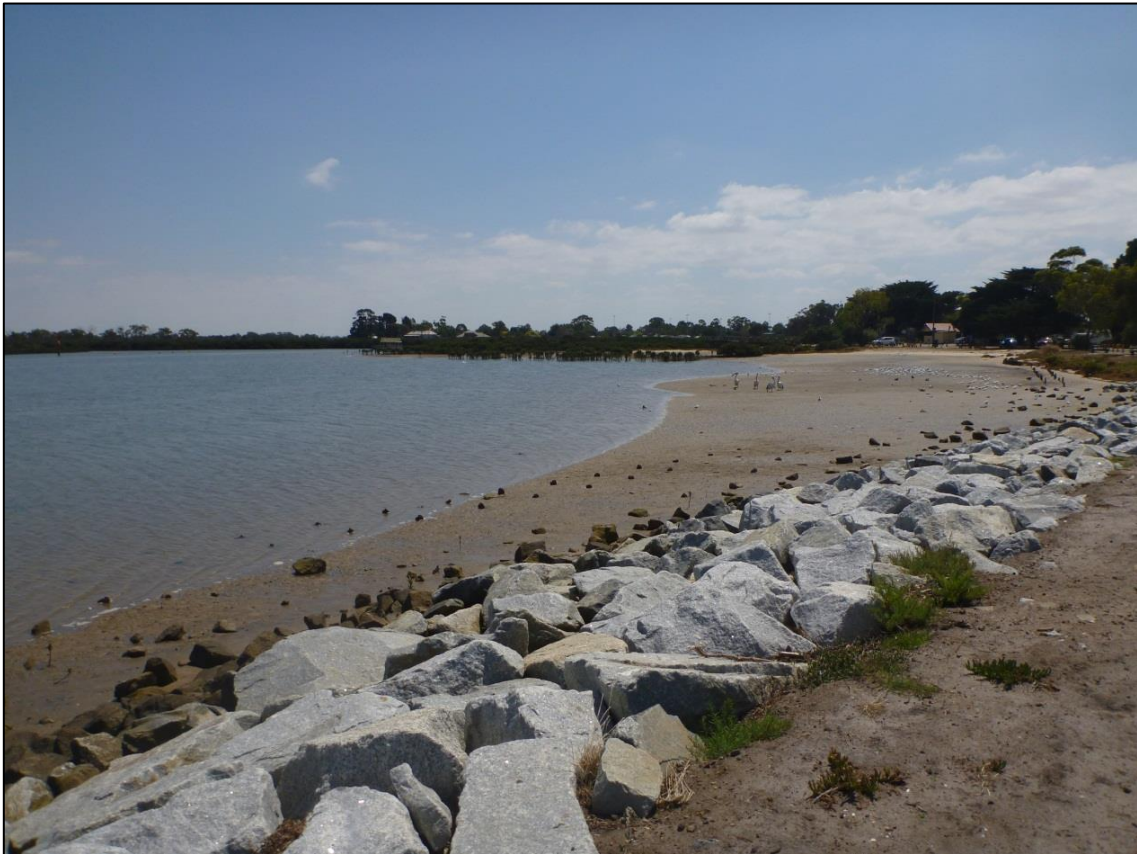
**Figure 3-10** Rock Revetment Structure at Tooradin adjacent to Boat Ramp

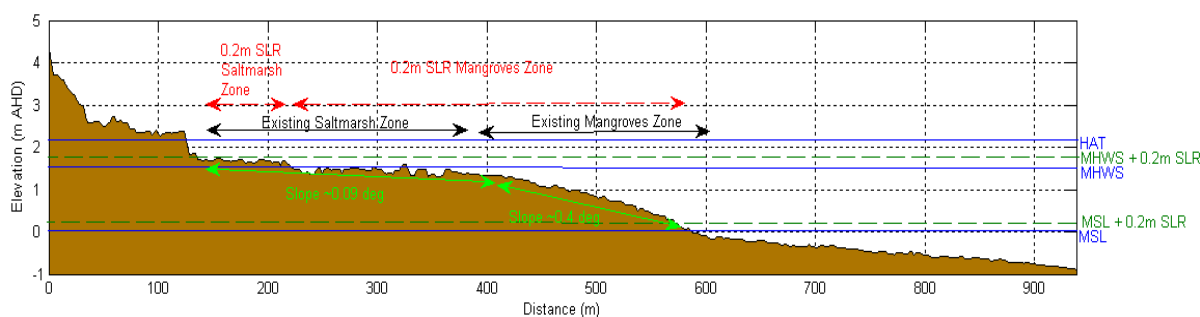
- Due to the very low gradient of the saltmarsh terrace zone, sea level rise scenarios of as little as +0.2 m would cause dramatic changes to the frequency of tidal inundation across the existing salt marsh zone. The frequency of inundation that would be generated across this zone would be considered generally unsuitable for saltmarsh.
- The tidal inundation regime across the profile would potentially remain within the range favourable for mangroves for sea level rise scenarios of +0.2 m (2040) and potentially up to +0.8 m (2100). This suggests that, setting aside major changes to wave climates and sediment transport processes on these shorelines, a fringe of mangroves may potentially persist to some extent on these shorelines.

**Figure 3-11 Analysis of Sensitivity of Coastal Wetland Shoreline Profile to Sea Level Rise**
