### 4.1.2 Coastal Geomorphology

## 4.1.3 Hydrodynamic Setting

## 4.2 Local Hazard Assessment

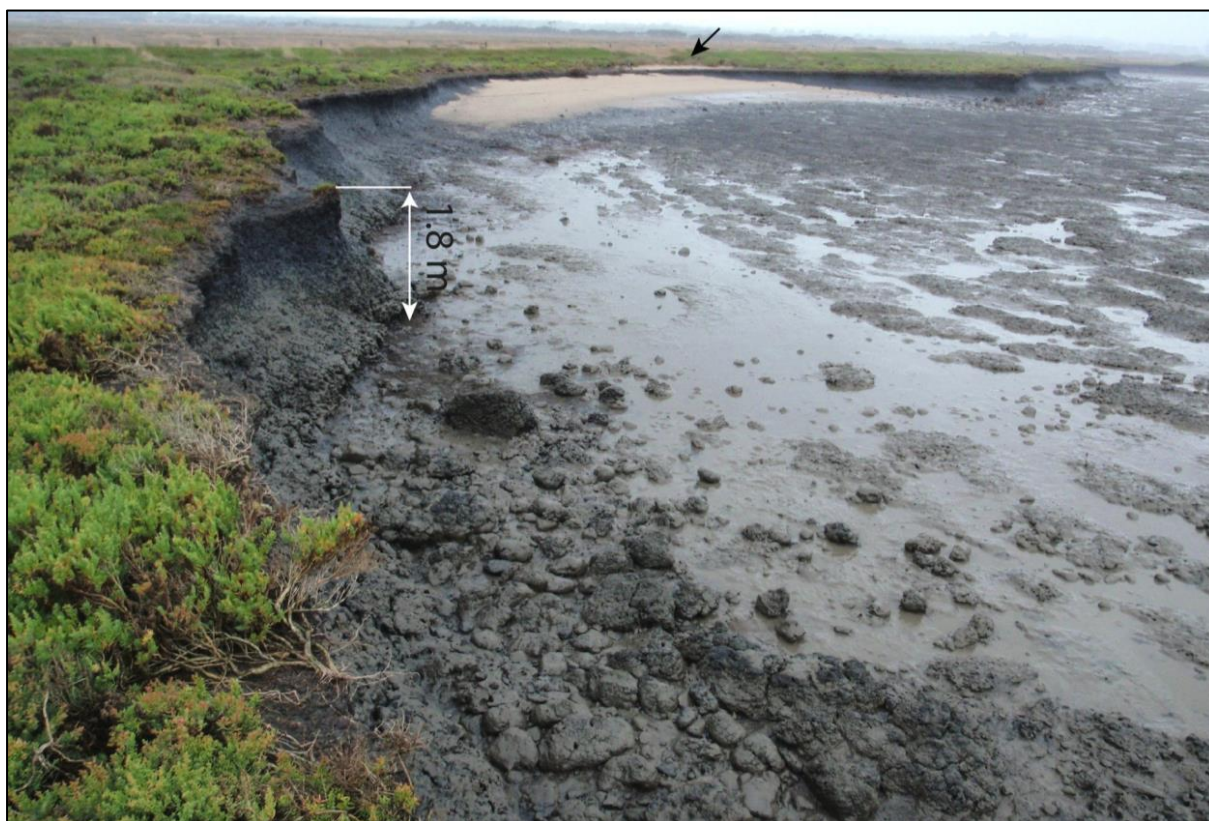
**Figure 4-5** Sand in Embayment and Cliff Base South of Lang Lang River (*the arrow shows the chenier of sand and shell at cliff top*)

In plan, the shoreline is crenulate with broad rounded weakly indented headlands separated by defined shallow embayments, which are often, but not restricted to, the mouth of a drain. Many of the bays have a veneer of coarse and shelly sand and at times there are small accumulations of sand at the base of headland cliffs. Sand in the embayments has a relatively long residence time and is derived from direct onshore rather than alongshore transport. Once deposited by high tide storm waves, the backwash and ebb currents are insufficient to remove it. Storm waves that overwash the cliffs and embayment heads form cheniers that further remove sand from the coastal transport system.

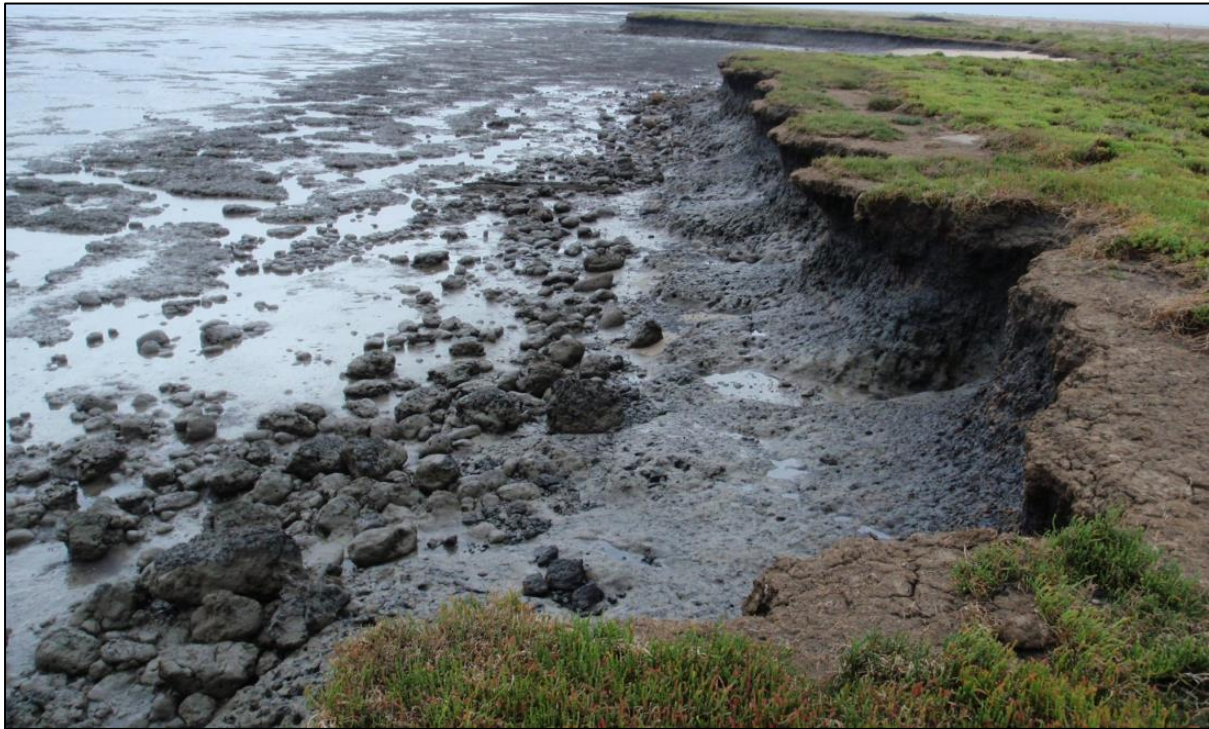
**Figure 4-10 Example of Cliff Overhang and Detached Blocks**

The erosion of the low earth cliffed shorelines is a result of direct wave action and processes involving wetting and drying of the cliff material as a result of tidal submergence/emergence, wave splash, runoff and groundwater outflows. These processes result in desiccation of the clay and organic materials which make up the low earth cliffs. Shrinkage and stress release fractures in the exposed material are susceptible to detachment by wave pressure during surges causing detachment of irregular blocks leading to slope failure and eventual dispersal of the blocks by wave run up and backwash (Figure 4-10). For further information on potential groundwater hazards in this area associated with sea level rise, refer to Part A, Report 5.

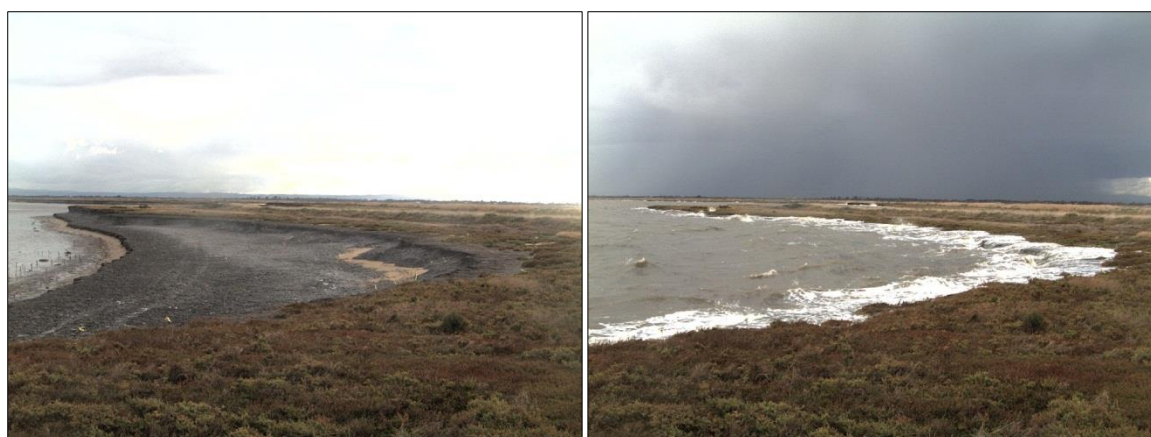
Backshore inundation initiated by coastal water level variations is a process that occurs occasionally under present mean sea level conditions along this section of shoreline, although the landward extent of inundation remains relatively limited. An example of minor backshore inundation in the study area is displayed in the photos in Figure 4-11 taken from the CSIRO monitoring project (Tomkins and McLachlan, 2013). The photos show a section of shoreline at low and high tides on 13 May 2013. The peak water level at Stony Point corresponding to the afternoon high tide on this date was approximately 1.4 m AHD. This water level could be expected to be exceeded multiple times in any one year on average and is approximately 0.7 m below the 1% AEP storm tide at Stony Point. Figure 4-11 is considered to highlight the potential for significant backshore inundation to develop along this section of the study area even under modest increases in mean sea level conditions.

13 05 2013 9:30am

13 05 2013 3:30pm

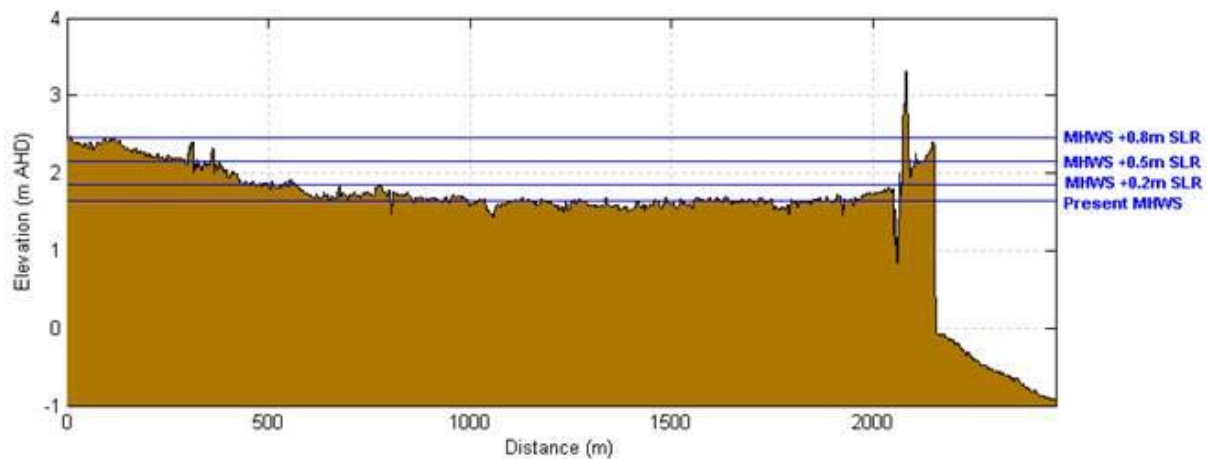
**Figure 4-12 Typical Topographic Section through Study Area in Relation to MHWS Tidal Planes**

From Figure 4-12 it can be seen that the narrow coastal reserve between the cliffed shoreline and the coastal levee is generally located at an elevation of between approximately 2.0 m and 2.2 m AHD. Comparison of these elevations with the predicted MHWS spring tidal planes in this region of Western Port demonstrate that for sea level rise scenarios of approximately +0.5 m (2050) or greater, frequent and extensive backshore tidal inundation could be expected to develop. Once this frequent, tidal inundation process is initiated, the frequent flood and ebb tide flows across the backshore landscape could be expected to result in relatively rapid dissection of the shoreline as tidal channels develop and expand in response to the extent of frequent backshore tidal inundation.

Table 4-2 displays the predicted MHWS tidal plane elevations for Lang Lang for the various sea level rise scenarios. Intersection of these tidal plane elevations with the topography of the study area provides an estimated upper maximum extent of shoreline erosion hazards that could be observed for this area.

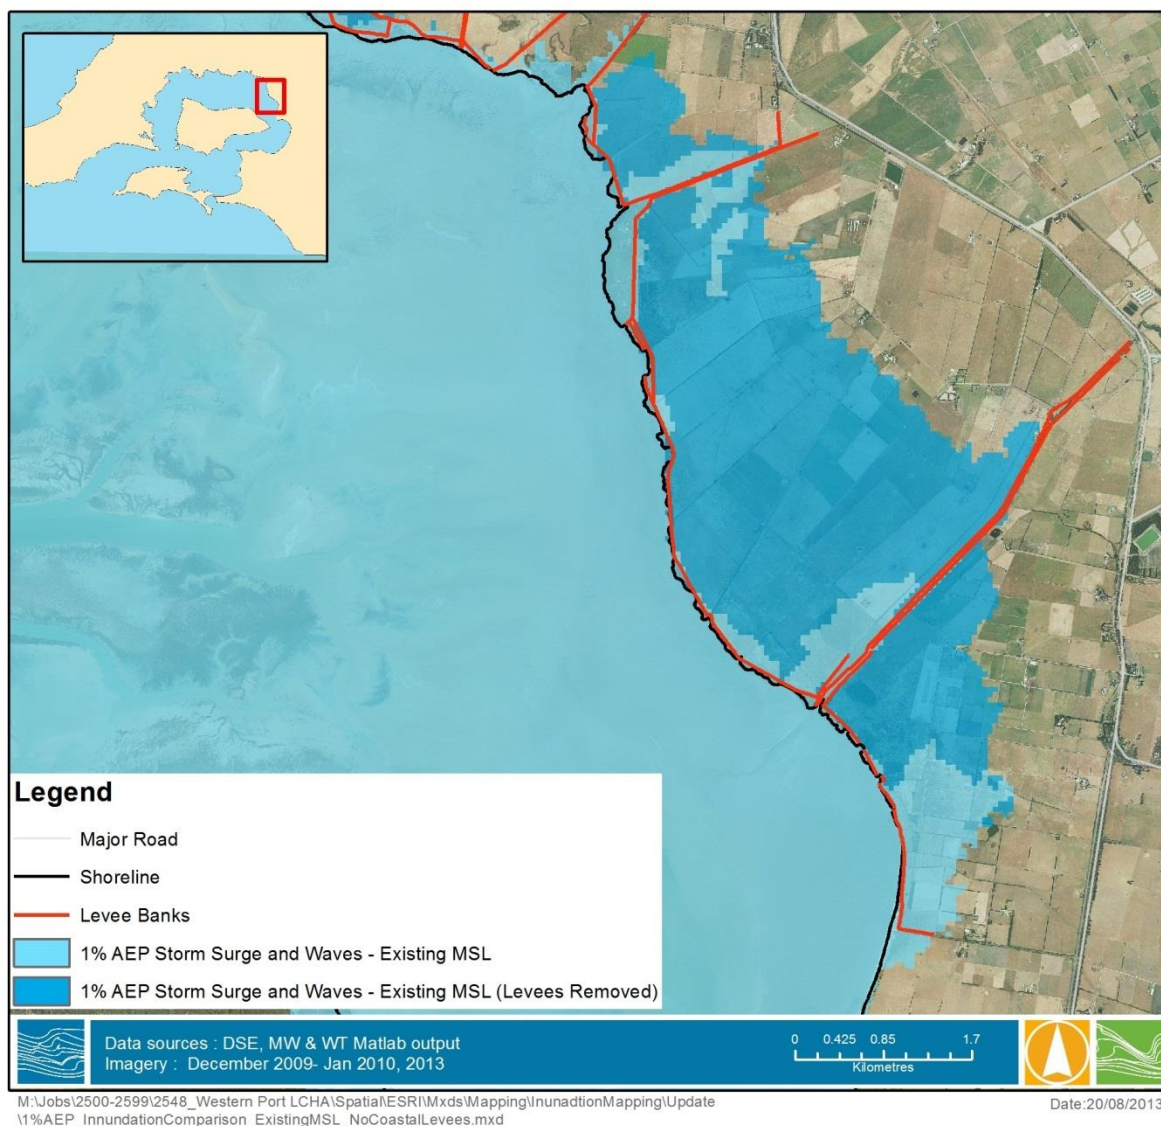
**Figure 4-13 Estimates of Coastal Inundation under Existing Mean Sea Level Conditions with and without Informal Coastal Levees and Embankments**

Figure 4-13 displays the sensitivity of the predicted 1% AEP storm tide inundation extent under existing sea levels with and without sections of the informal coastal levees and embankments. The informal levees and embankments that were considered were identified from the topography and are also shown in the figure. It can be seen that under existing mean sea level conditions, the 1% AEP storm tide scenario would potentially generate very significant inundation extents within the study area without the presence of these structures.

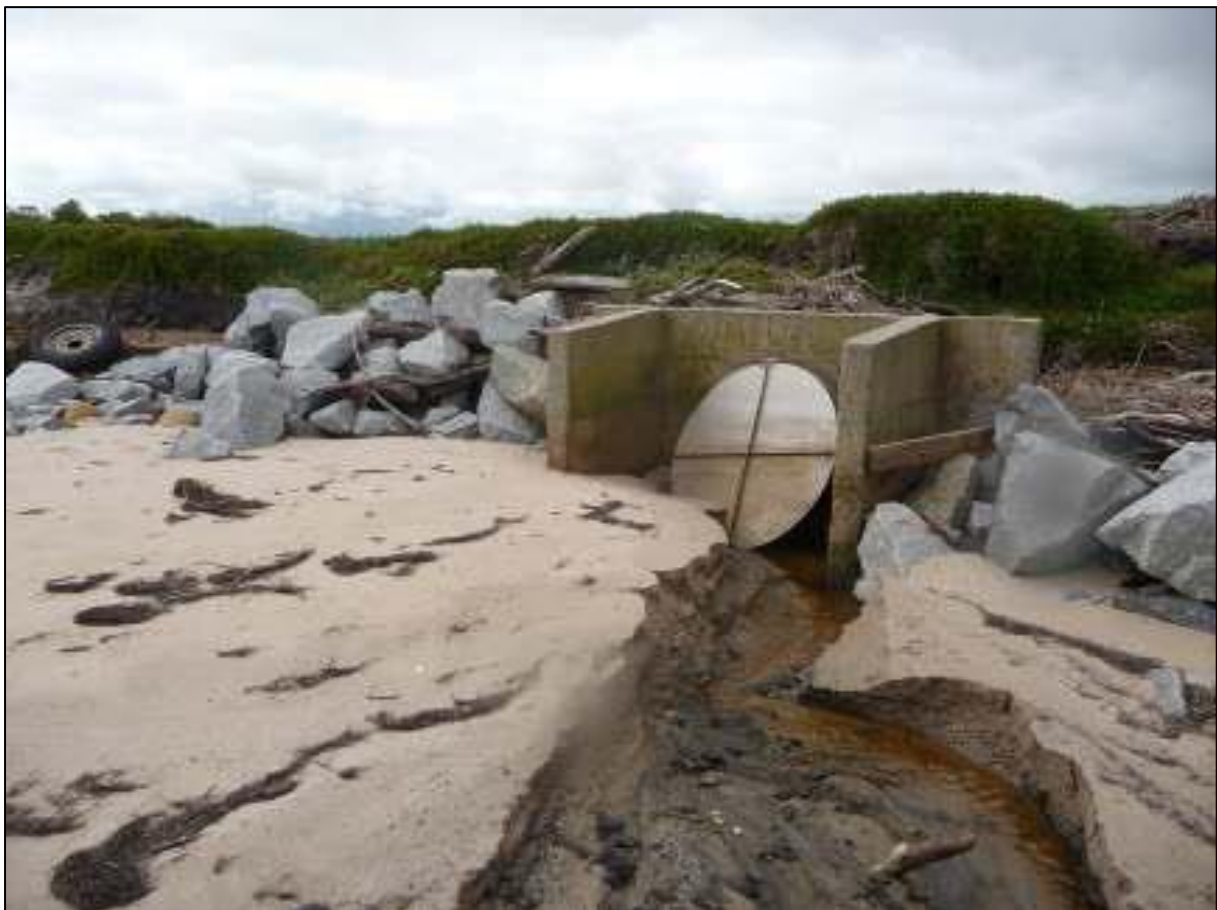
**Figure 4-15 One Way Tide Gate on Minor Drain Emptying to Western Port (Note poor condition) (GHD, 2010)**

Future management and adaptation of the extensive drain networks will also significantly influence the extent of potential backshore inundation. At present, multiple minor drainage outlets to Western Port occur through small culvert and causeway structures. Some of these minor drainage outlets have one way tidal gates to prevent ingress of coastal water (Figure 4-15). The potential for significant backshore inundation that could occur due to the propagation of coastal waters through unmanaged or poorly maintained drain outlets is considered another significant source of uncertainty.

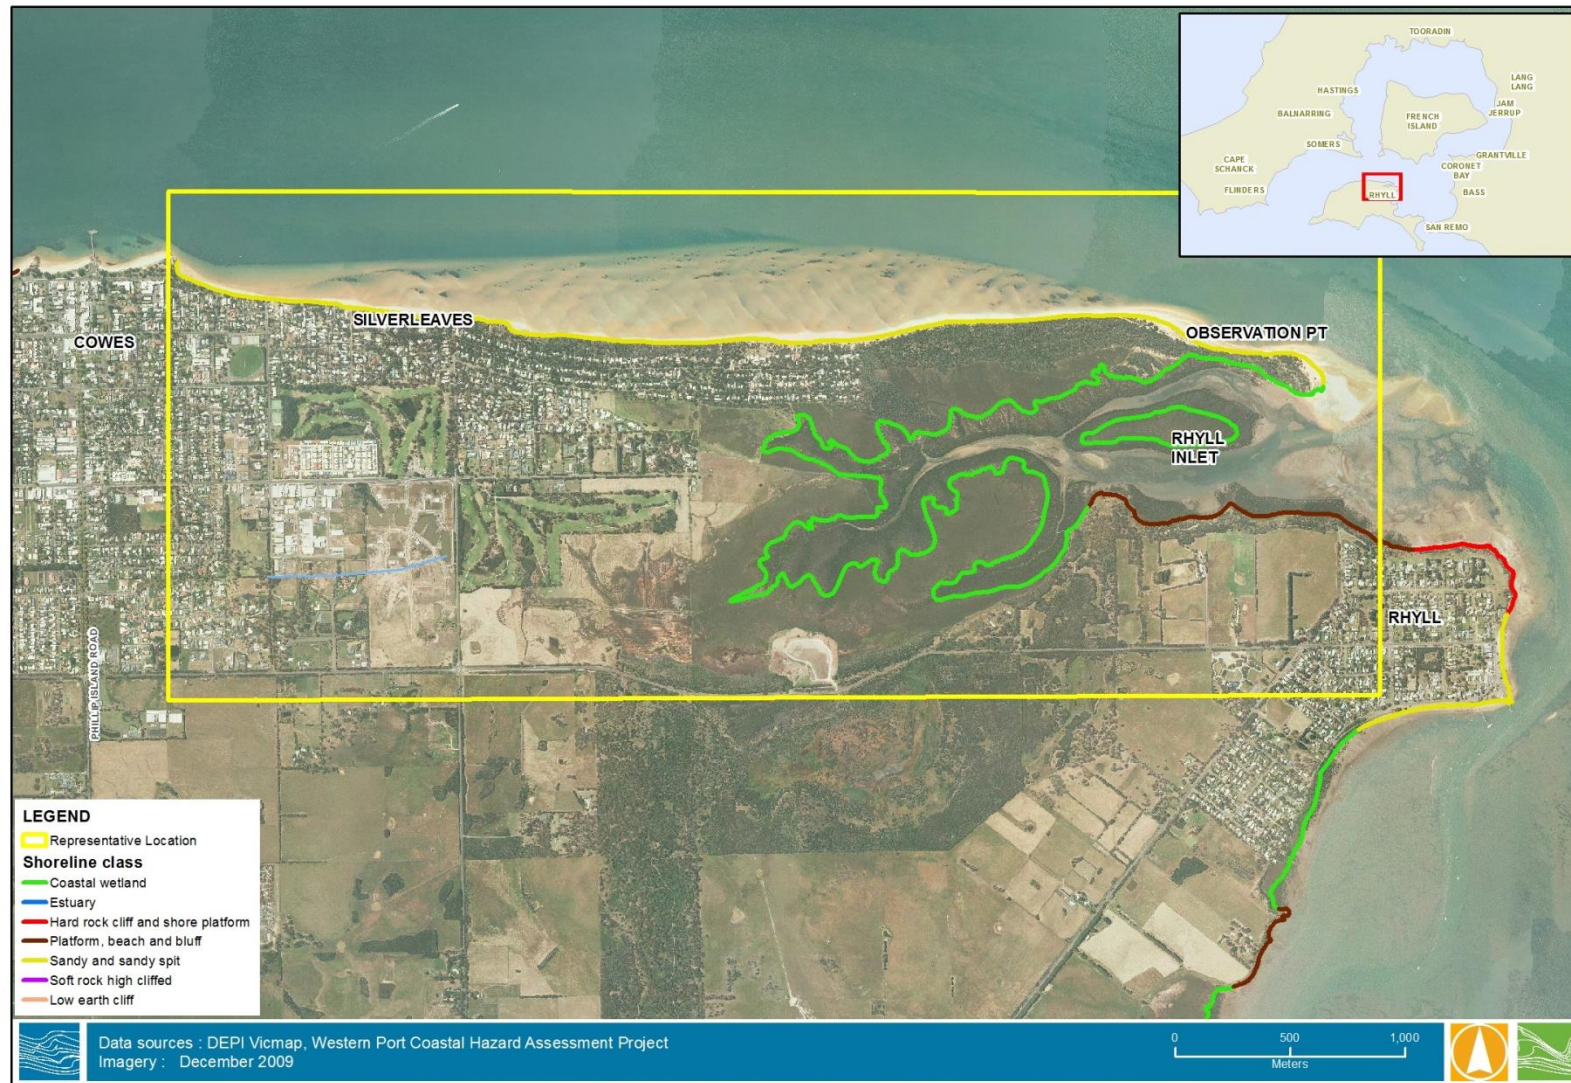
**Figure 5-1 Rhyll Inlet and Silverleaves Study Area Locality Plan**

The Rhyll Inlet and Silverleaves representative location shoreline extends from Erehwon Point at Cowes to Observatory Point and includes the shorelines of Rhyll Inlet as displayed in Figure 5-1. This study area incorporates a major sandy spit landform and extensive coastal wetland shoreline class as identified in the Part A assessment.

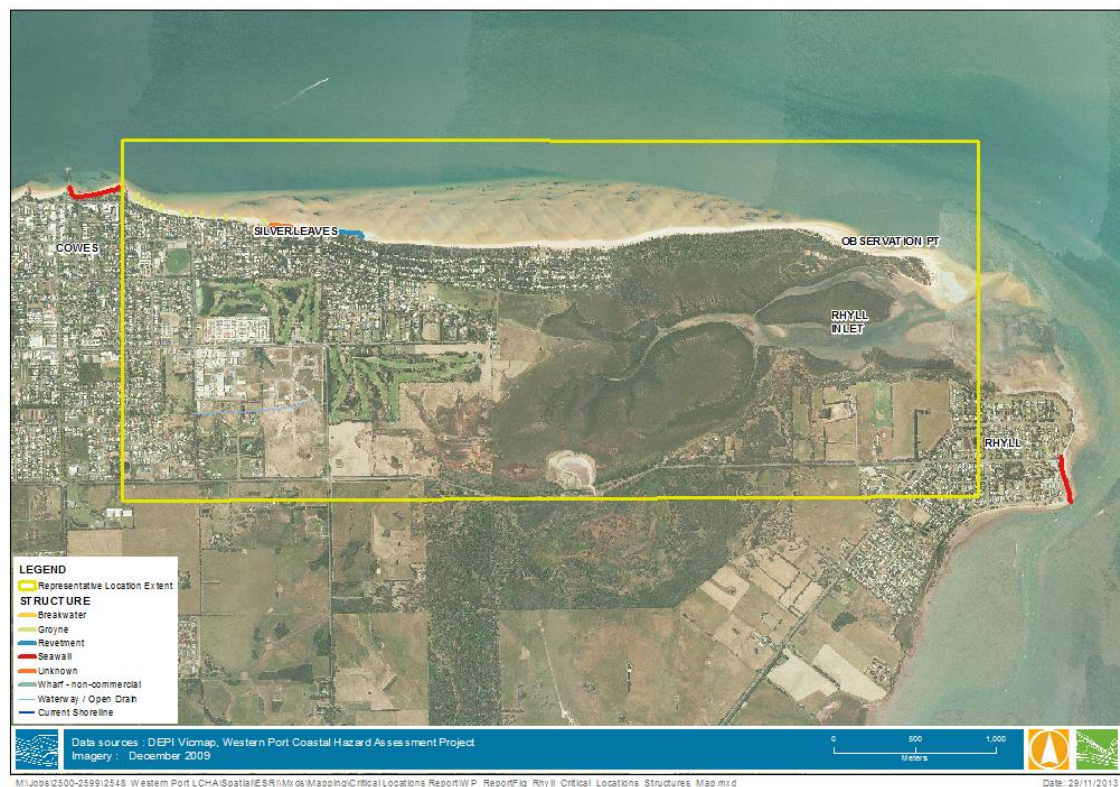
**Figure 5-6**      **Extent of the Coastal Structures in the Rhyll Inlet-Silverleaves Study Area**

A range of coastal protection structures currently exist along the western end of the contemporary spit shoreline. The structures have been constructed primarily to protect residential development that has been threatened by variability in the shoreline position associated with the migration of backshore sand lobes. The existing coastal structures as defined by the DEPI coastal asset database are shown in Figure 5-6. There is also a rock revetment associated with the groyne structures which while not included in the DEPI asset database, is a significant coastal structure in this location.

The coastal protection structures include timber groynes, rock revetments and timber seawalls. The structures have been constructed to varying engineering standards and are currently in varying states of repair. A review of these structures, their condition and function, and future management options including the impacts of future sea level rise has been detailed in a previous study (Water Technology, 2011). An overview is provided herein.

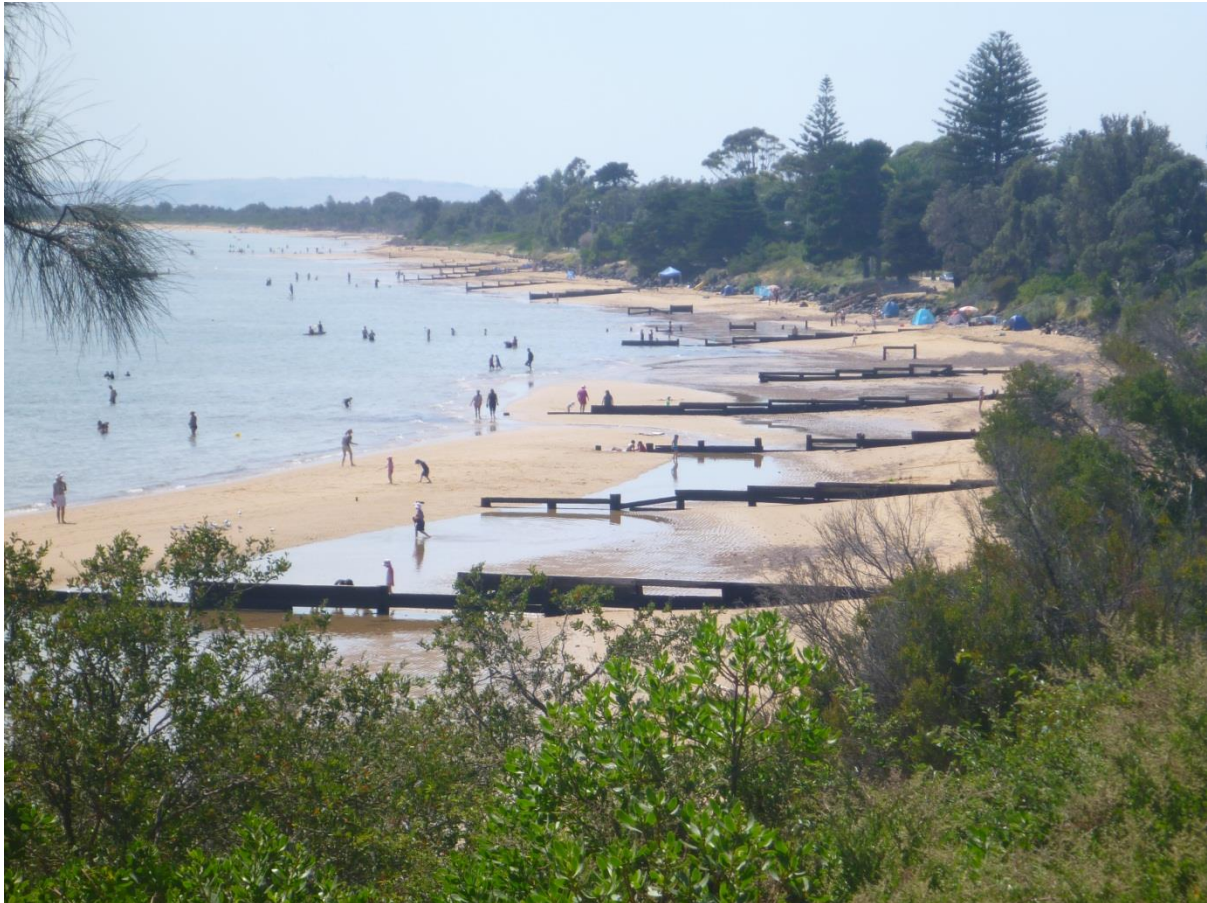
**Figure 5-7 Timber Groyne Fields, east of Erehwon Point in January 2014**

The timber groyne field extends east of Erehwon Point, and consists of a mixture of piked and horizontal slat and single and two row palisade construction types. At the time of the previous report (Water Technology, 2010) the protrusion of the groynes above the sand was limited, however as can be seen in Figure 5-7 the majority of structures are currently exposed over the significant sections of their length.

The structural condition of the groynes is now considered generally poor with the majority of the piles and slats displaying signs of significant deterioration. A number of groynes have been partly removed due to safety concerns associated with their poor condition following an audit by the Department of Sustainability (Parsons Brinckerhoff, 2008).

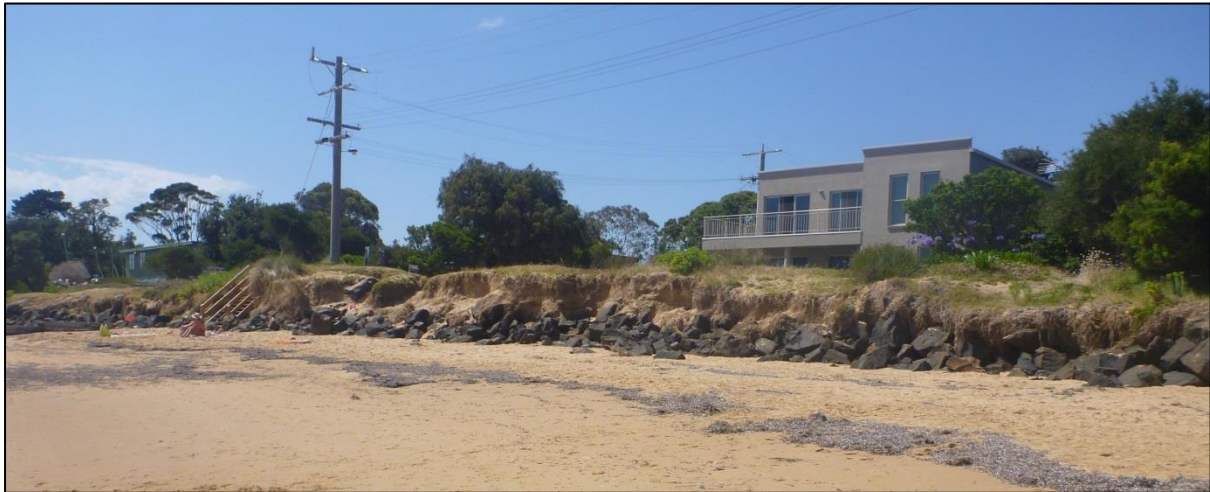
**Figure 5-8 Example of rock revetment along Silverleaves shoreline**

The rock revetments have been constructed from quarried basalt with a wide distribution of rock sizes and crest levels. In places wave action has dislodged smaller rocks from the structure and these are now lying seaward of it on the beach. Evidence of overtopping by wave action is visible, resulting in erosion behind the revetment and associated slumping in some isolated locations.

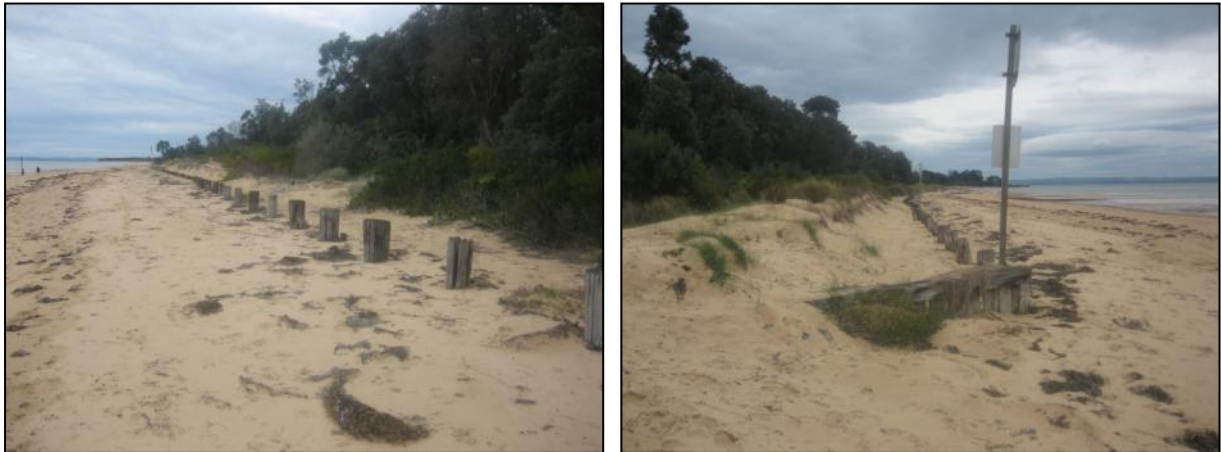
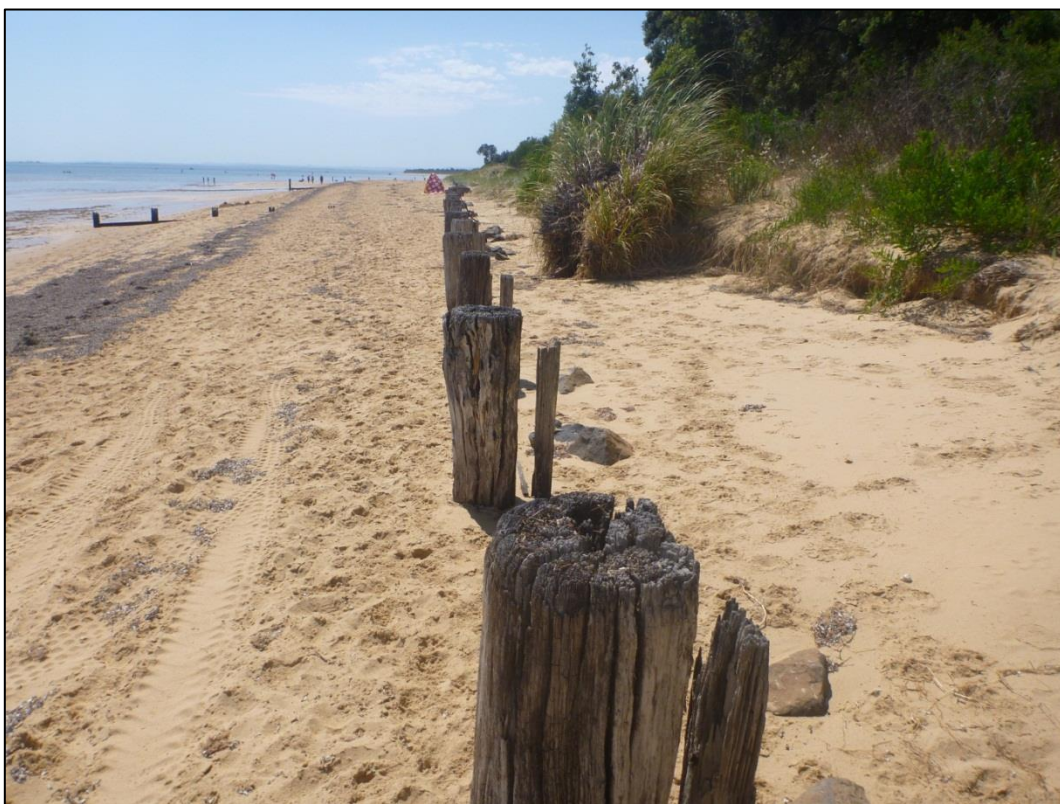
**Figure 5-9 Timber Walls between Rose Avenue and Coghlan Road**

The Division of Ports and Harbours are believed to have constructed a timber wall between Rose Avenue and Coghlan Road in the 1940's. The PICS study showed beach profiles were lowered in front of the timber wall and high tides were flooding behind the timber wall and reflected waves were scouring the beach sand in front of the walls. Figure 5-9 shows the condition of the timber wall looking west towards Rose Avenue in 2010 and then again in January 2014. The photos show the shoreline is highly variable, with significant accretion shown in the 2010 photo shown by the burial of the wall and colonisation by vegetation, while more recently storm events during 2012/13 have resulted in erosion of sand and additional exposure of the upper part of the structure.

August 2010

January 2014

This is discussed in terms of the coastal processes in the following section, particularly the backshore sand lobe migration which dominates sand erosion and accretion along this shoreline.

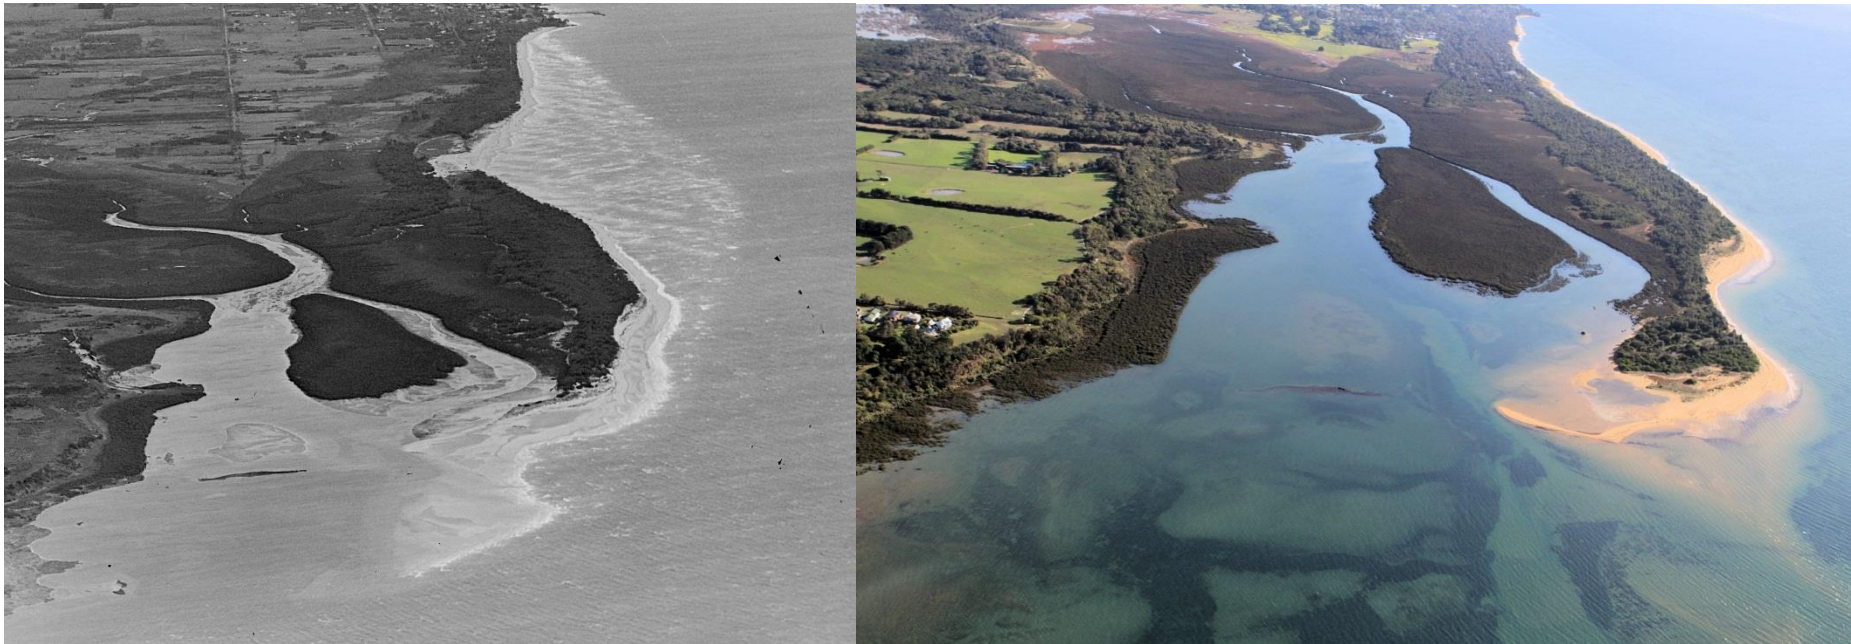
**Figure 5-10 Comparison of Silverleaves and Rhyll Inlet between 1947 (left) and 2013 (right)**

- The significance of the migration of backshore sand lobes is readily apparent with significant variability in shoreline position observed over the historical photographic record.
- Continued infilling of the Silverleaves Bight is apparent, however, shoreline protection works constructed to the west have resulted in acute terminal erosion impacts in this area.
- The maximum extent of shoreline variability observed over the photographic period is approximately 50 m.

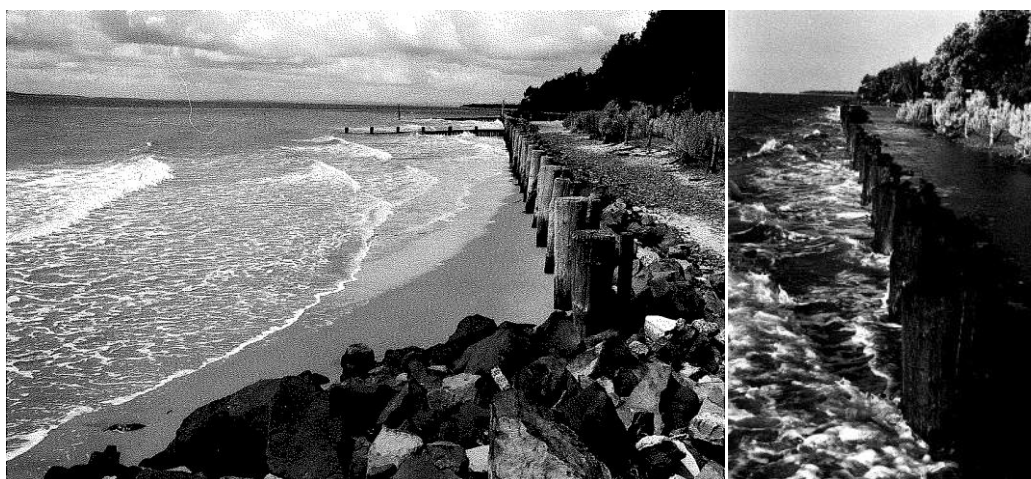
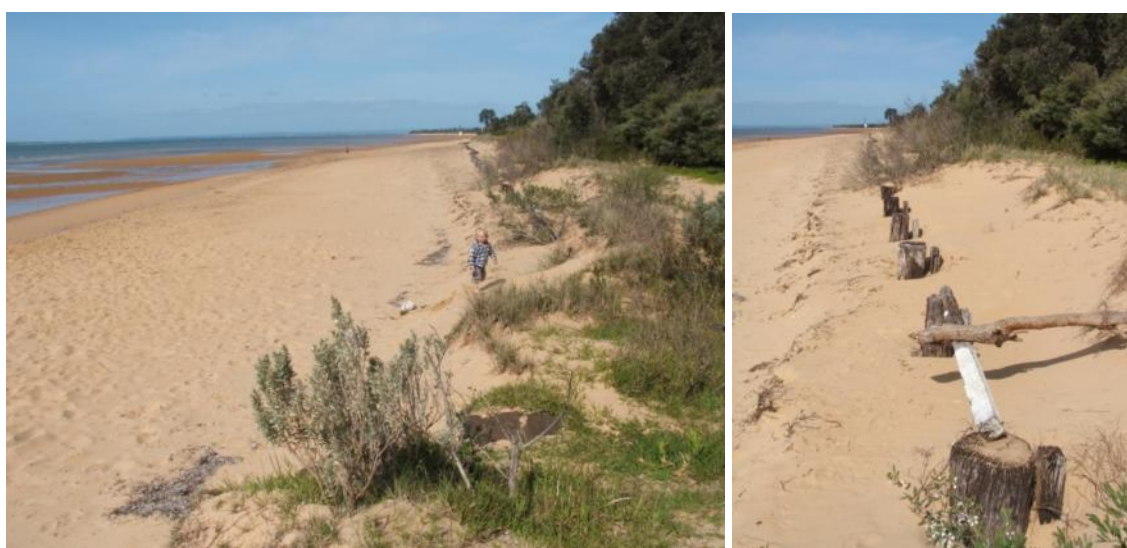
An example of the significance of backshore sand lobes along the spit shoreline can be appreciated in Figure 5-12 which compares photos taken in 1986 with contemporary photos (Water Technology, dated 2010) at the approximate same location, comparing the width and condition of shoreline east of Rose Avenue. In the mid-1980s this section of shoreline was undergoing significant shoreline recession; however, the longshore migration of a broad lobe of sand at this same location by 2010 has resulted in the development of a wide sandy beach. The differences captured in the photos highlight the decadal scale of variability that can be attributed to the migration of backshore sand lobes.

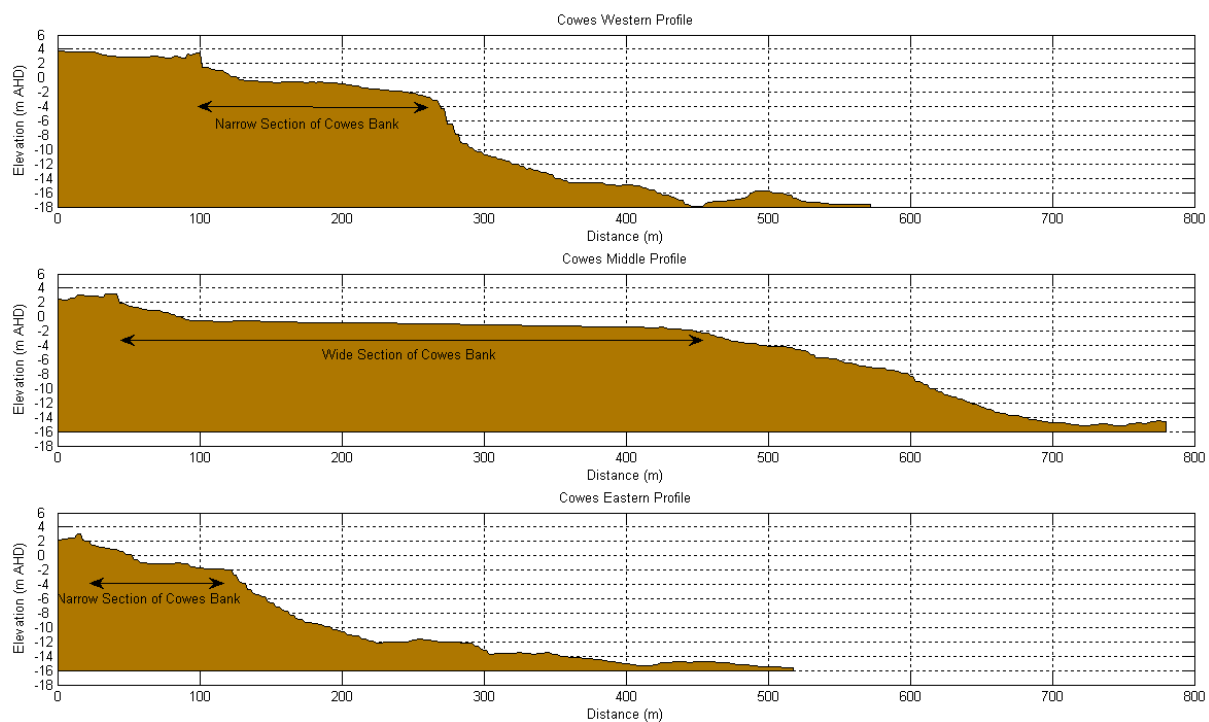
**Figure 5-13 Three Cross-Section Profiles across Cowes Bank**

Longshore sediment transport modelling was undertaken along the contemporary spit shoreline to try to develop an understanding of the sediment transport budgets along the spit and test the sensitivity to sea level rise this century. The modelling was undertaken at three profiles along the contemporary spit shoreline and across Cowes Bank; Western, Middle and Eastern. The three cross shore profiles are displayed in Figure 5-13 and demonstrate the variability in the width of Cowes Bank along the spit shoreline.

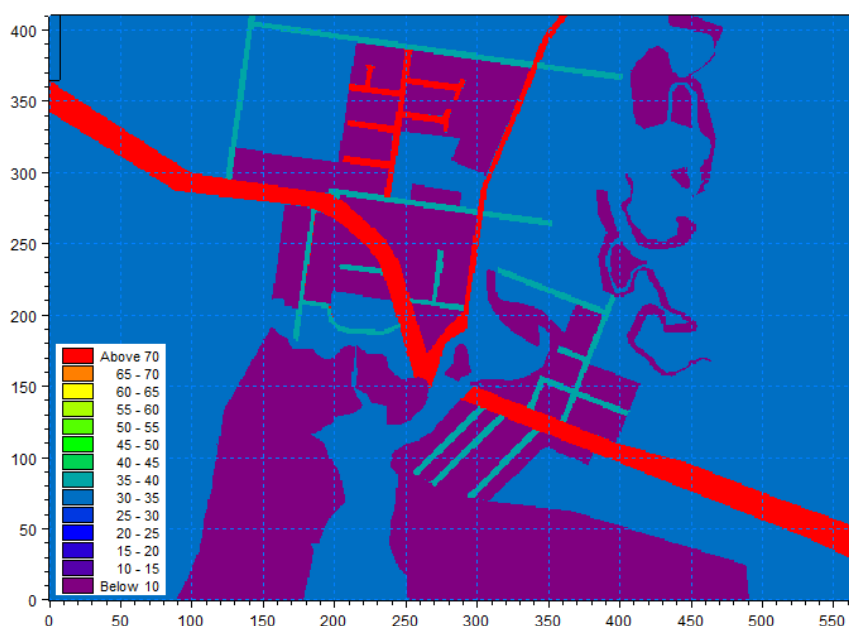
**Figure 2** Example of the Refined Roughness Map around Tooradin. The values represent Manning's M Values.

The refined roughness values were adopted from standard values and based on previous experience of flood modelling in this location. Roughness is typically specified as a Manning's 'n' value, however within the software tool used for this assessment the roughness is specified as a Manning's M value which is  $1/n$ .

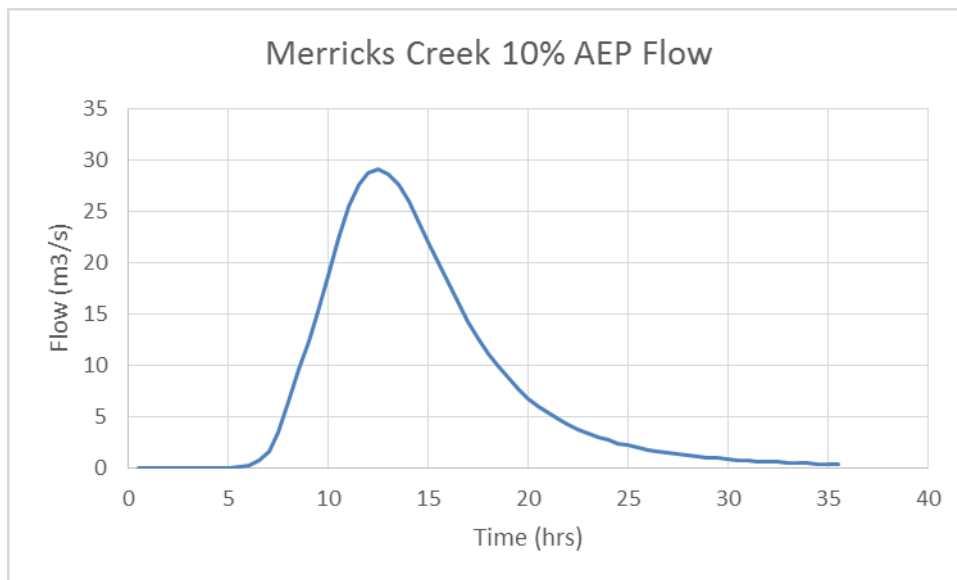
**Figure 0-2 10% AEP Design Flow Hydrograph**

The resulting 10% AEP design flow hydrograph is shown in Figure 0-2.
